CASE STUDY ON RESOLVING OIL WHIRL ISSUES ON GAS COMPRESSOR

GE Oil & Gas

Abstract

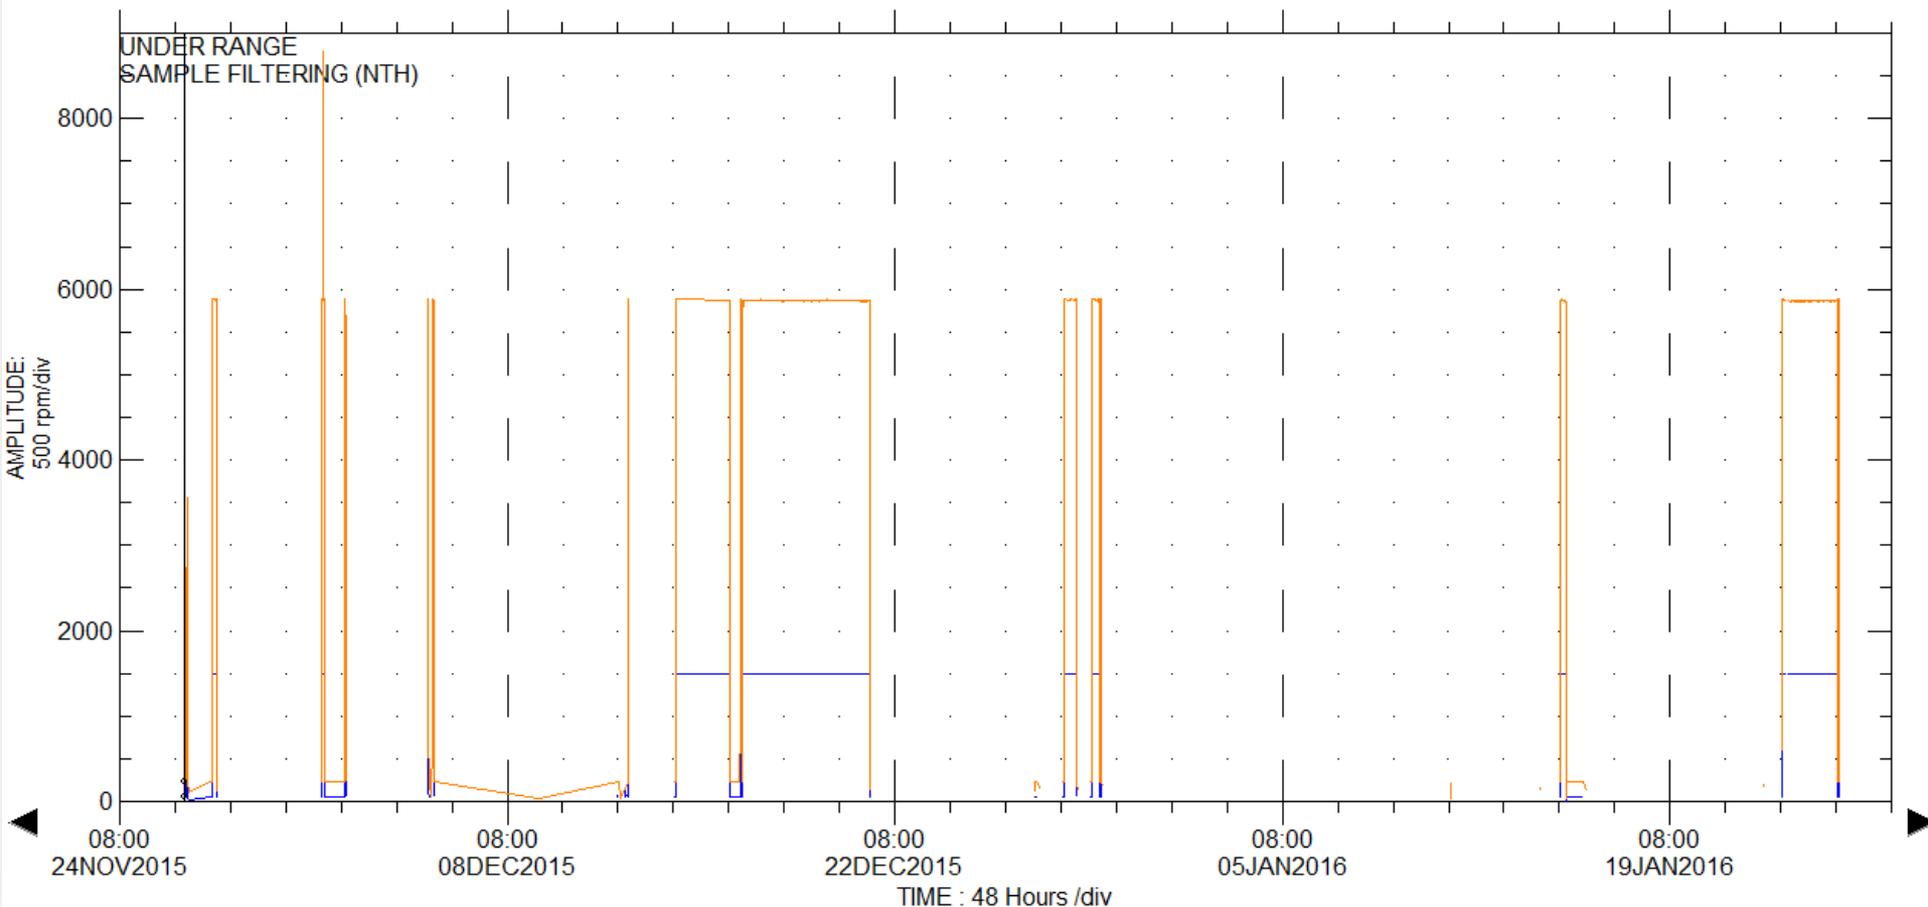
Compressor Overall Vibration (Abnormal)

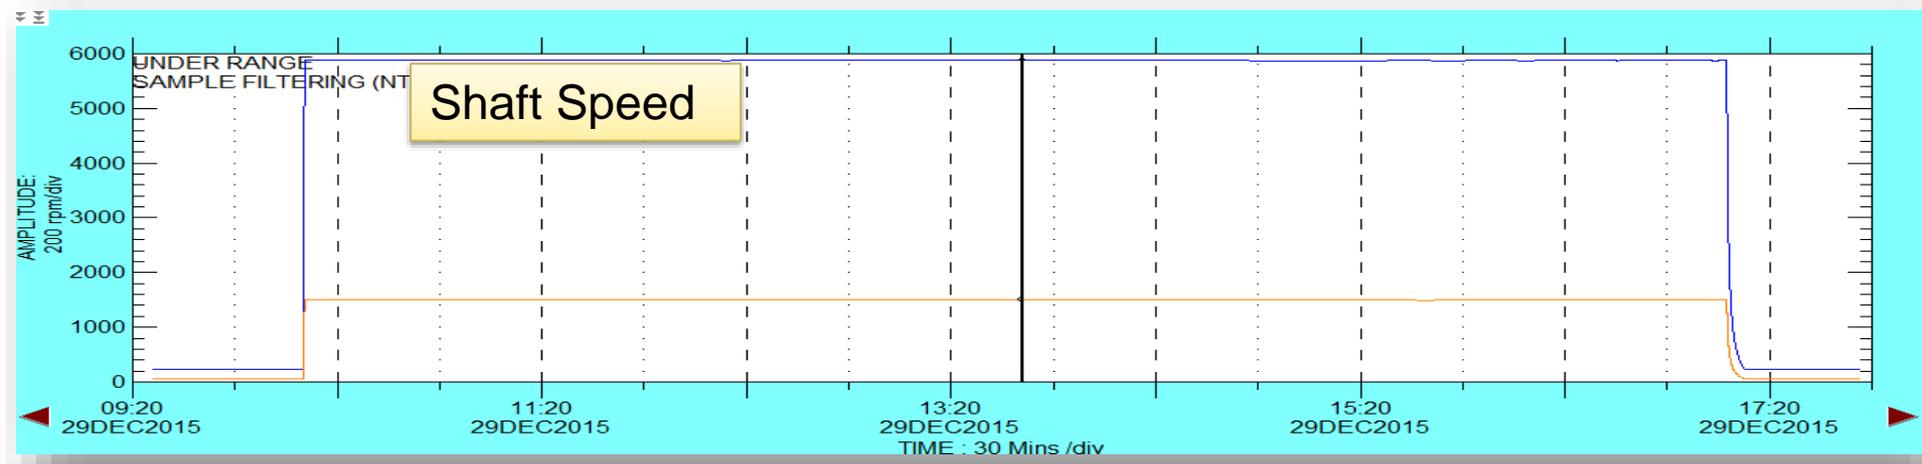
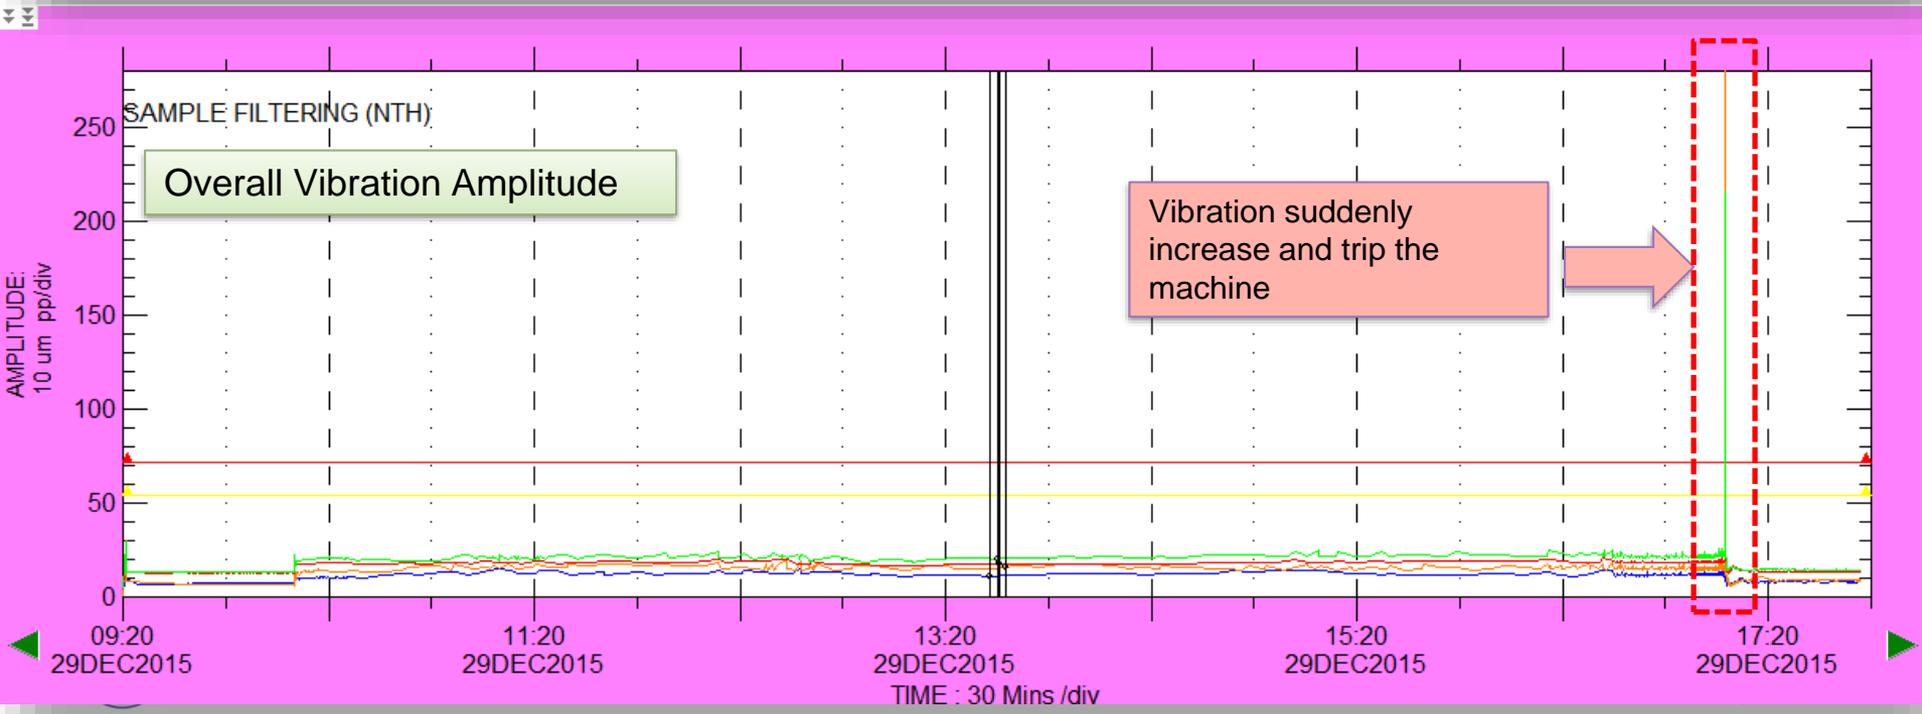
Shaft Speed vs. Vibration Amplitude Trends: **Vibration suddenly increased**

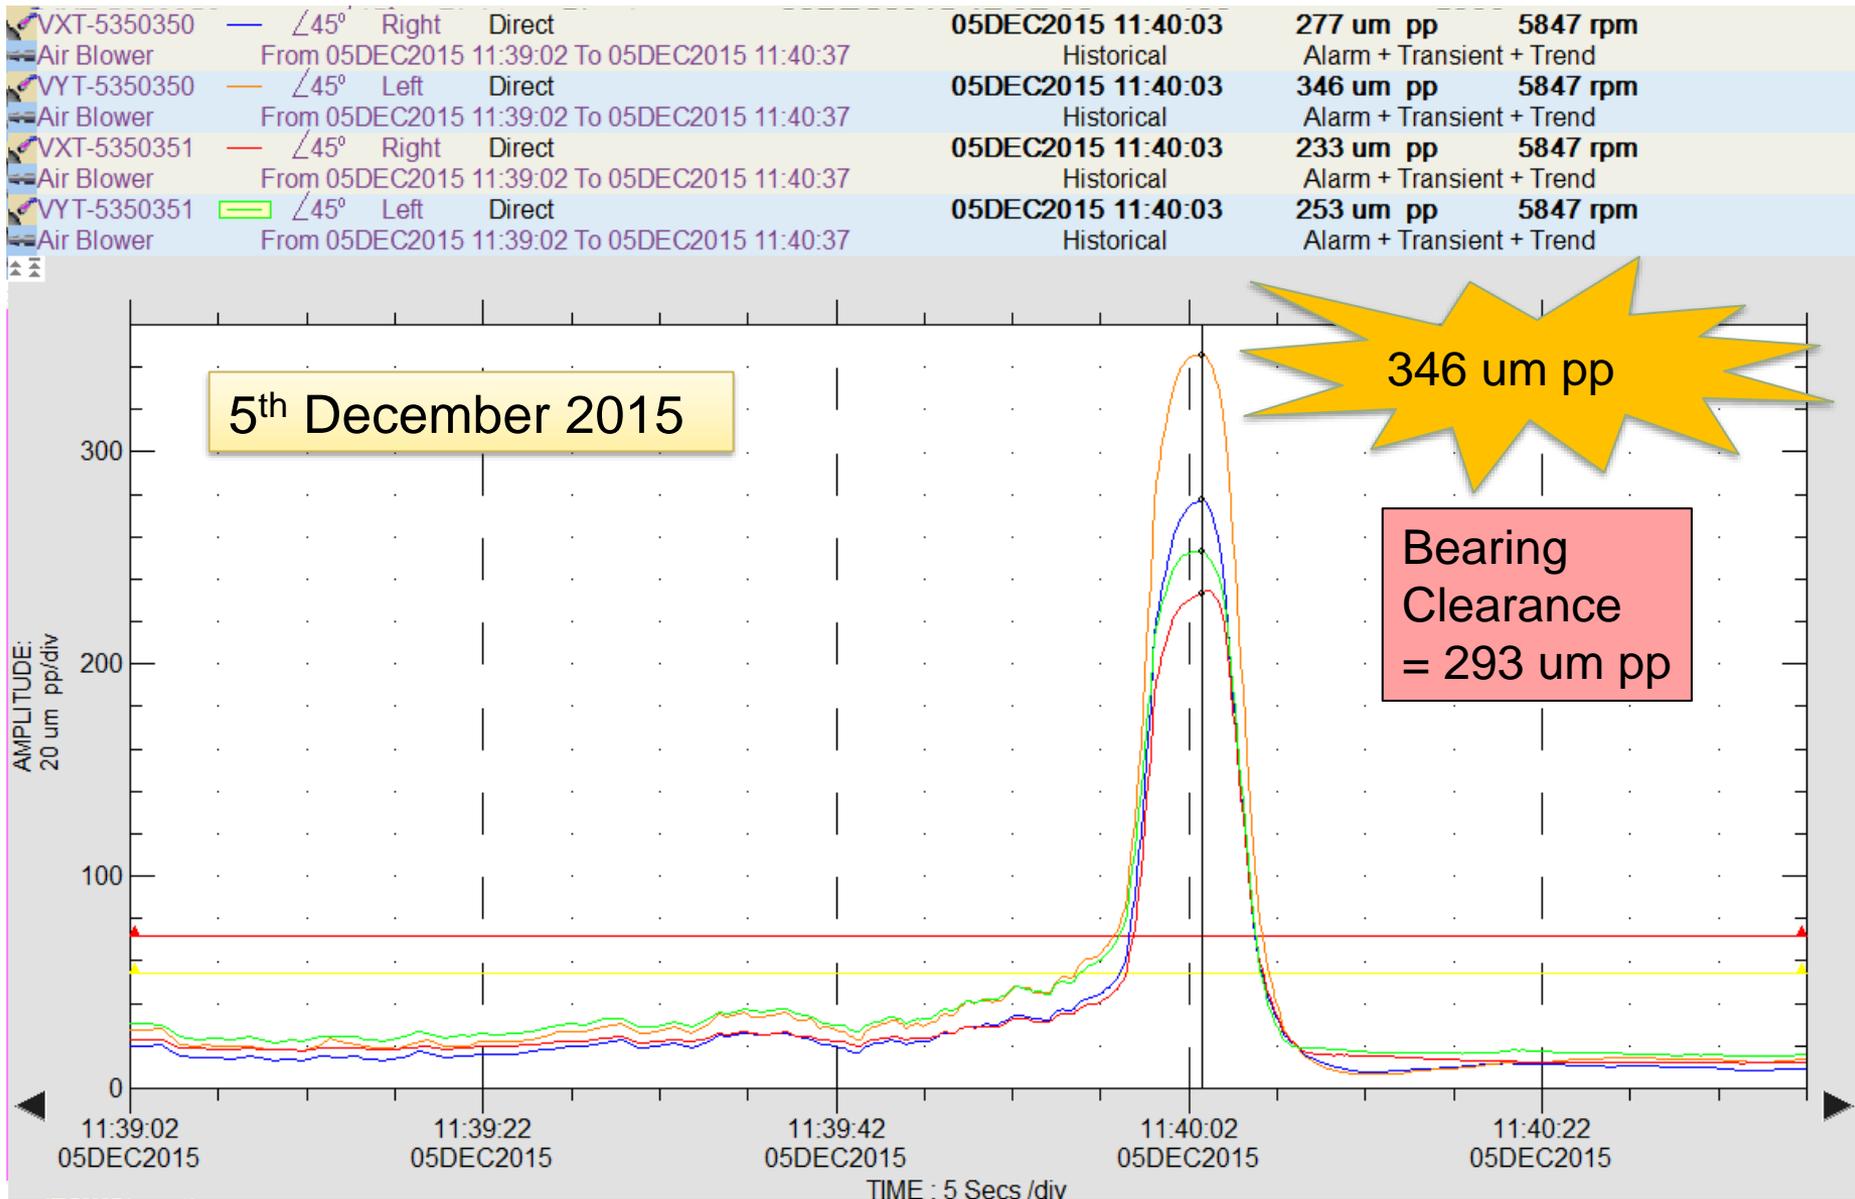
Vibration Amplitude: Higher than bearing Clearance (>293 um)

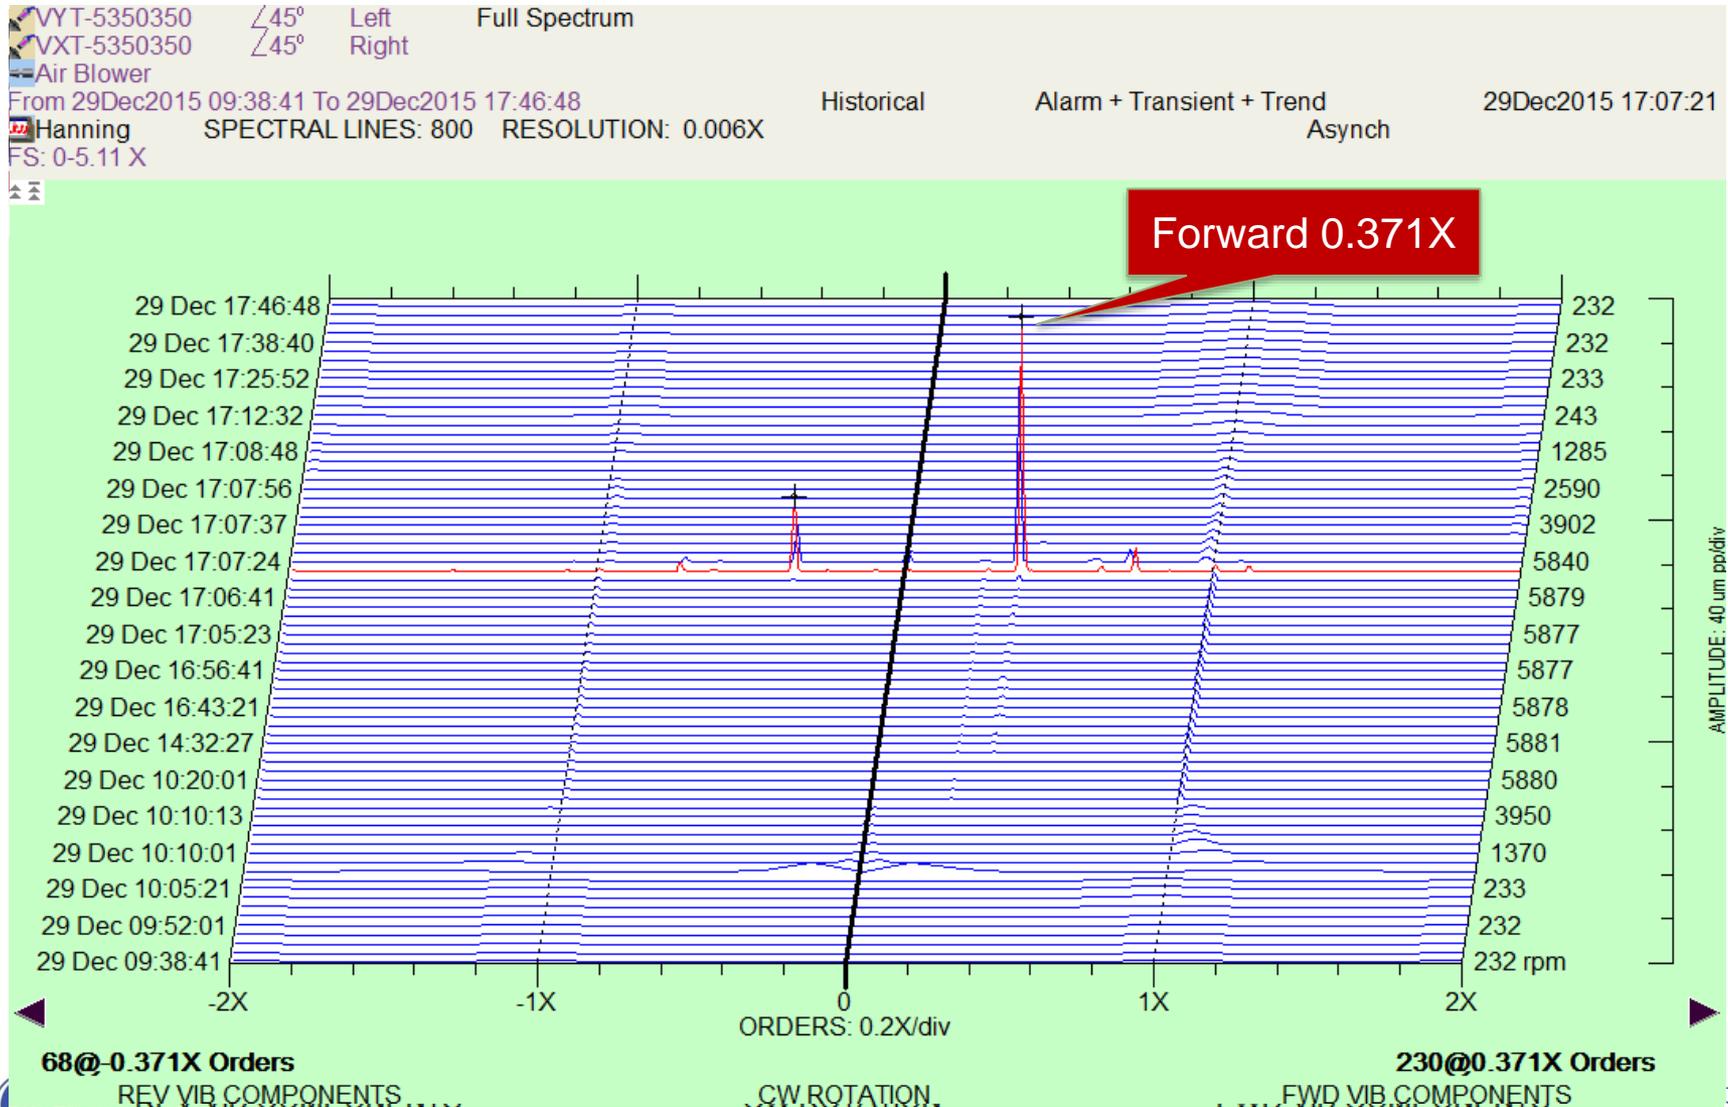
Vibration Spectrum: 0.371X Dominant

**Fluid Induce Instability – Whirl
(most likely at DE bearing)**

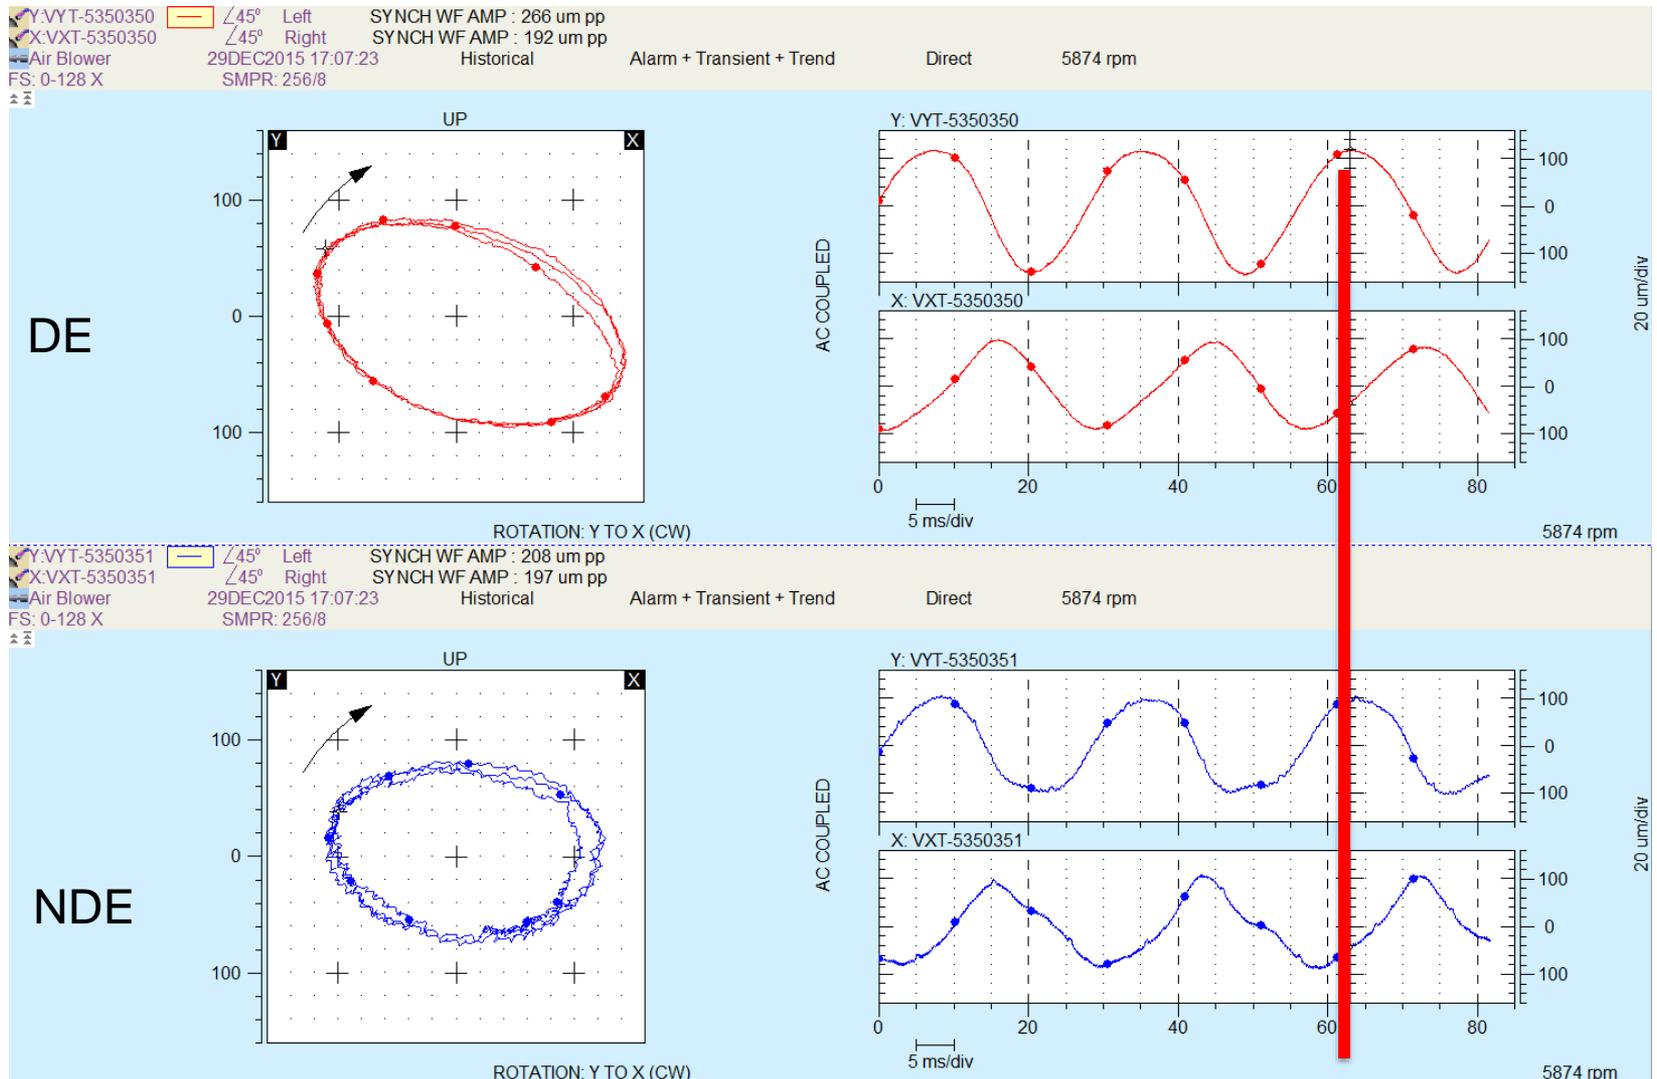
DE and NDE orbits: In-Phase

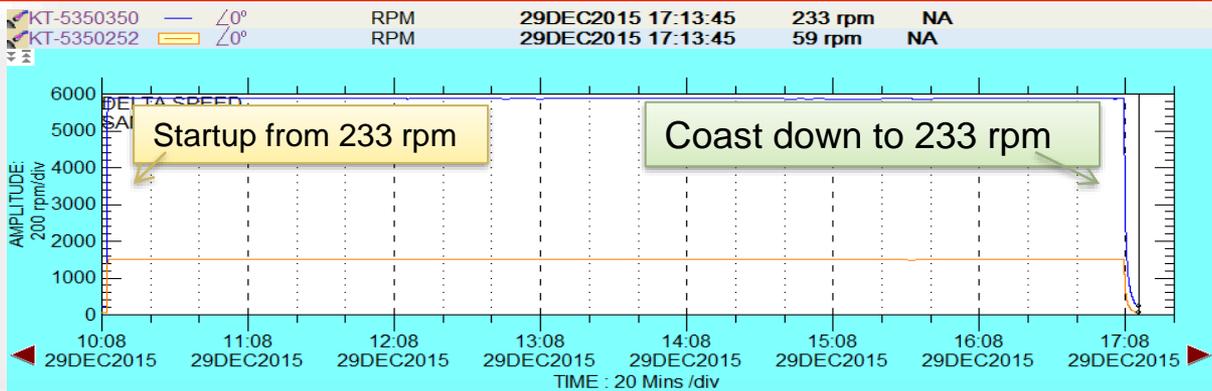
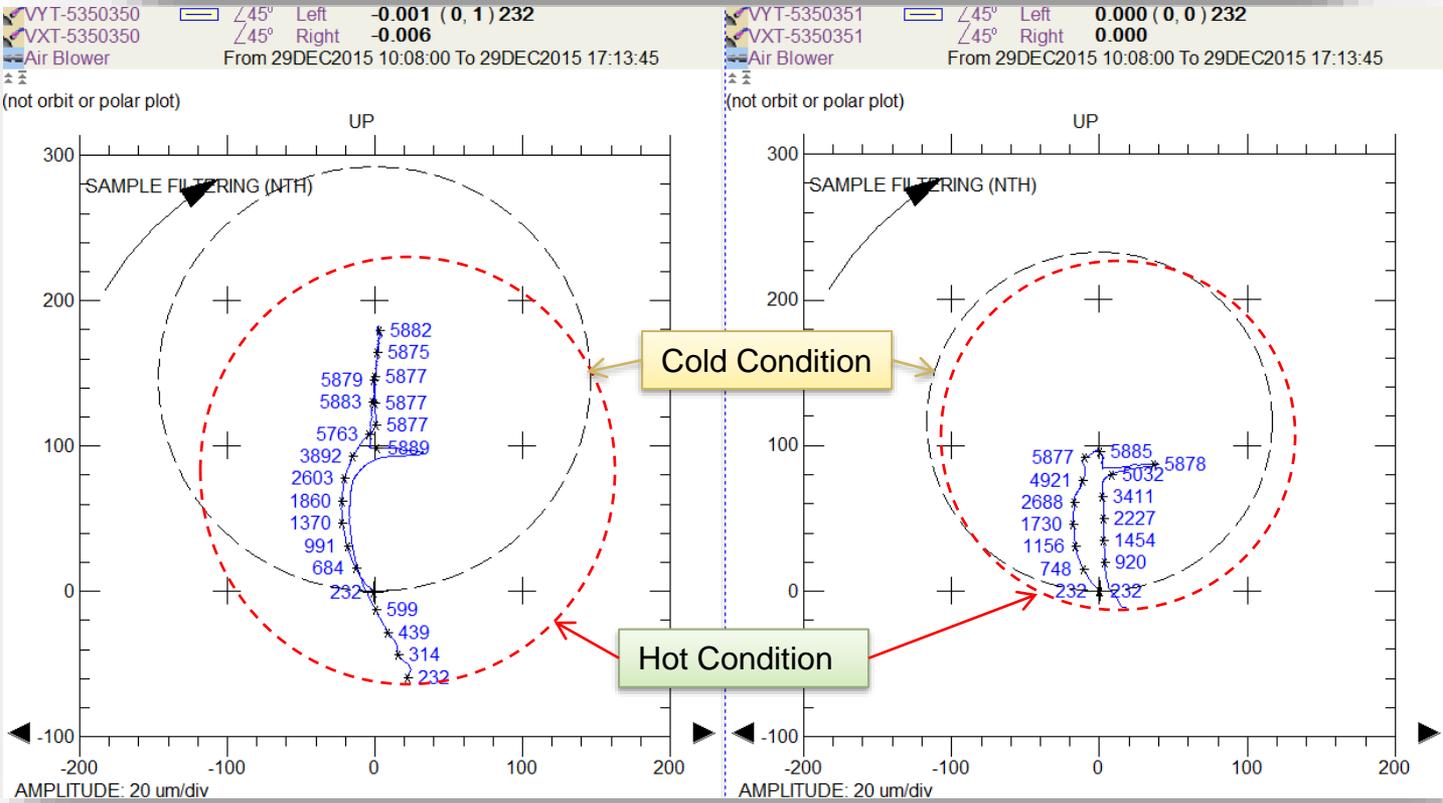
Average Shaft Centerline: Significantly Different btw Cold and Hot Condition

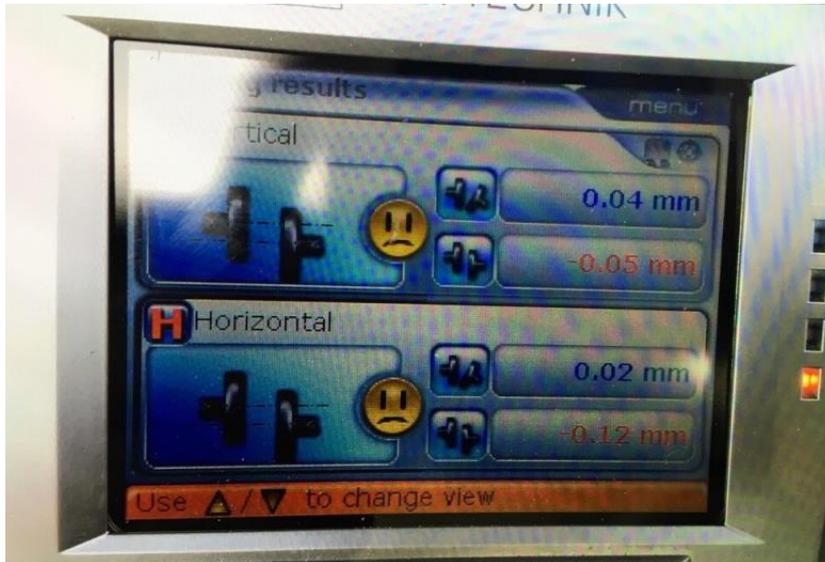
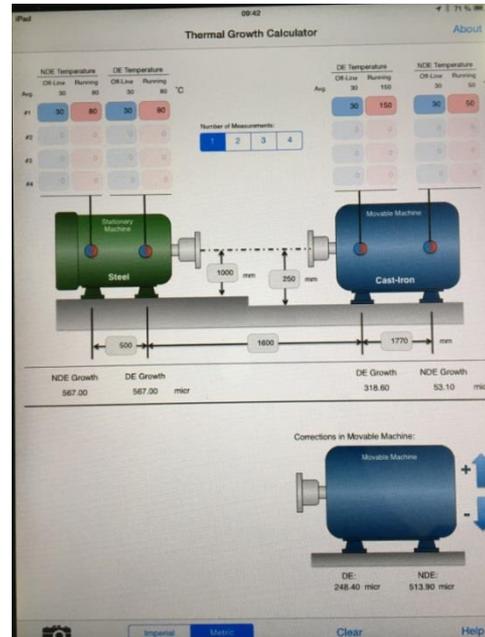
Alignment Confirmation

Nom		
No 1	<i>pt. install.</i>	-0.40
No 2	<i>Redhead</i>	-0.52
No 3	<i>+0.2 shim</i>	-0.42
No.4	<i>-0.2 + 0.5 shim</i>	-0.05

After adjust
alignment, problem
still existed.

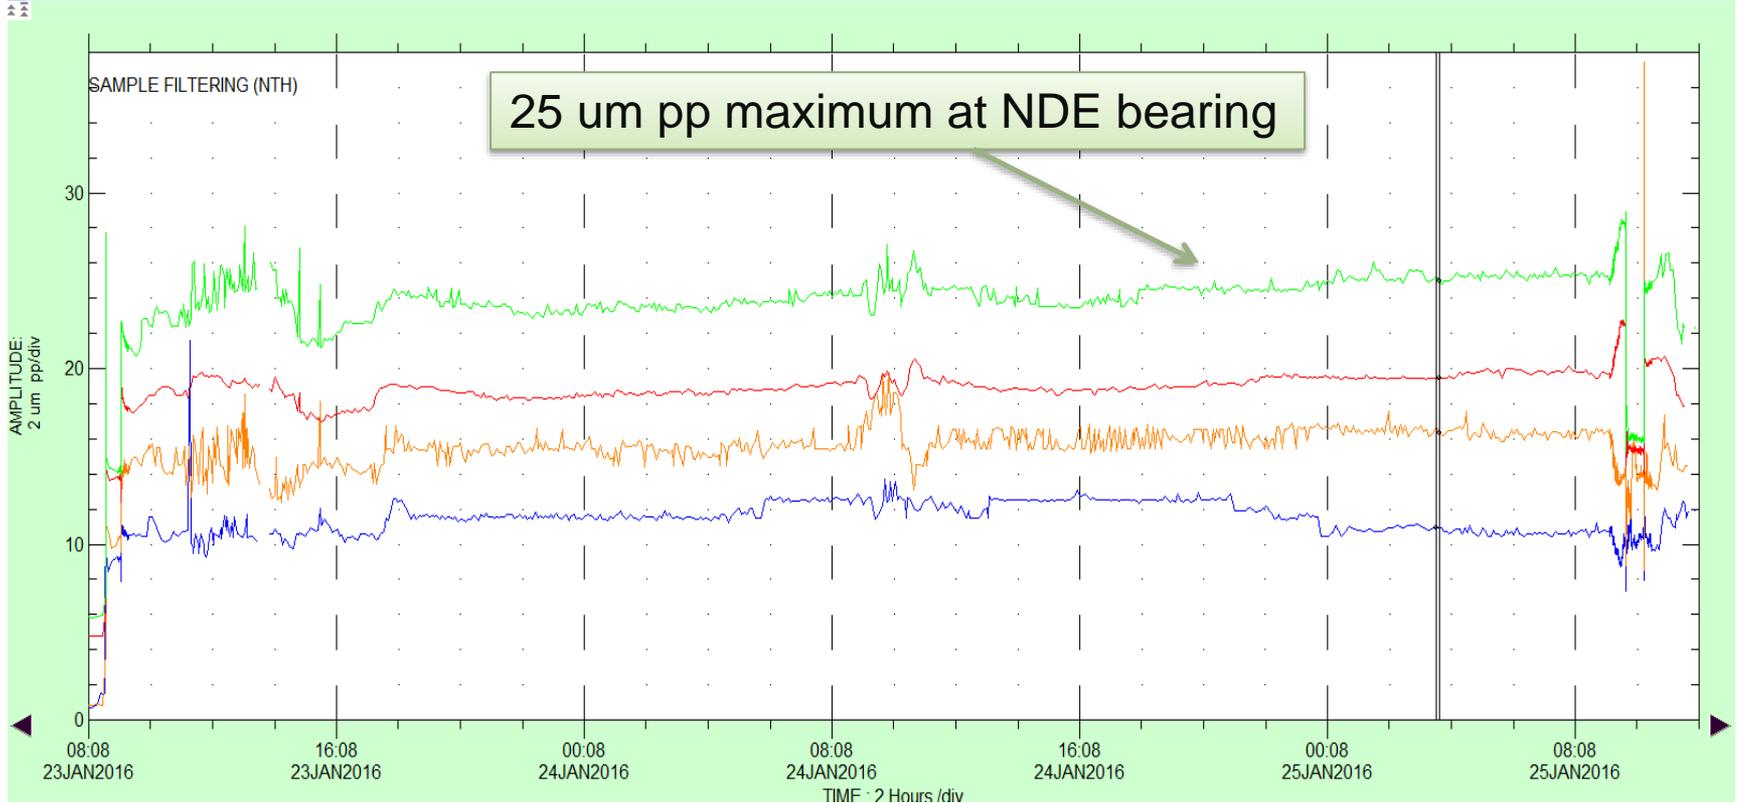
Vibration Amplitude, 25 um pp (1 mil pp)

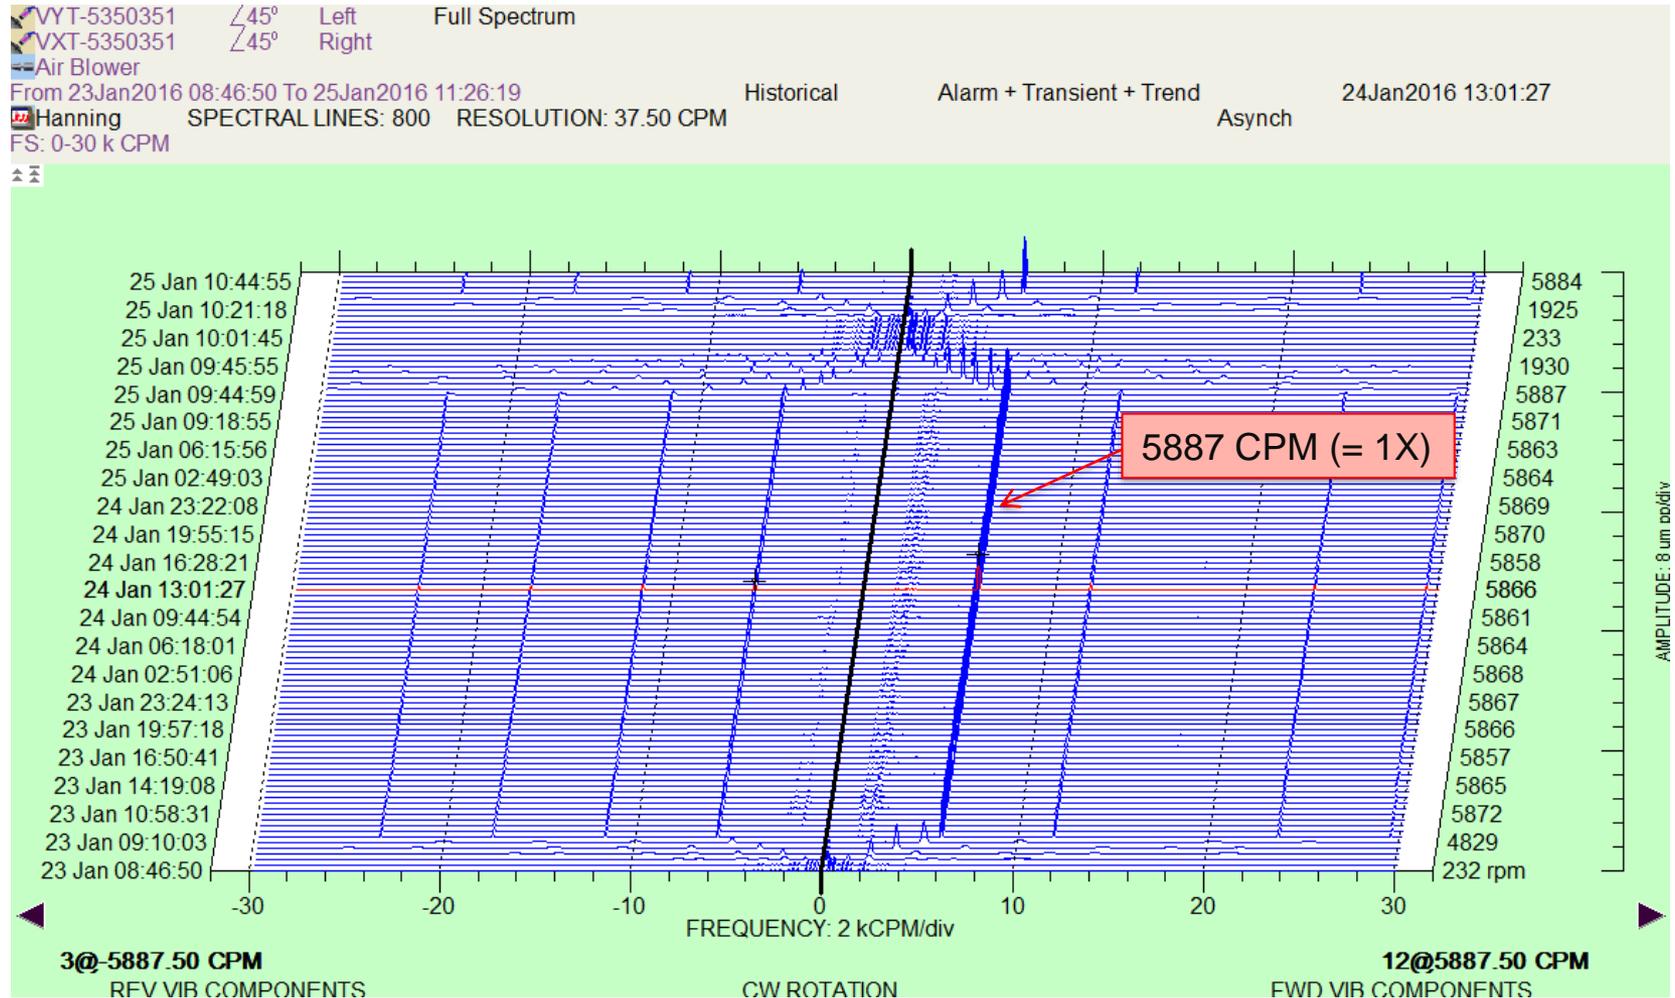
Frequency, 1X dominant (normal)

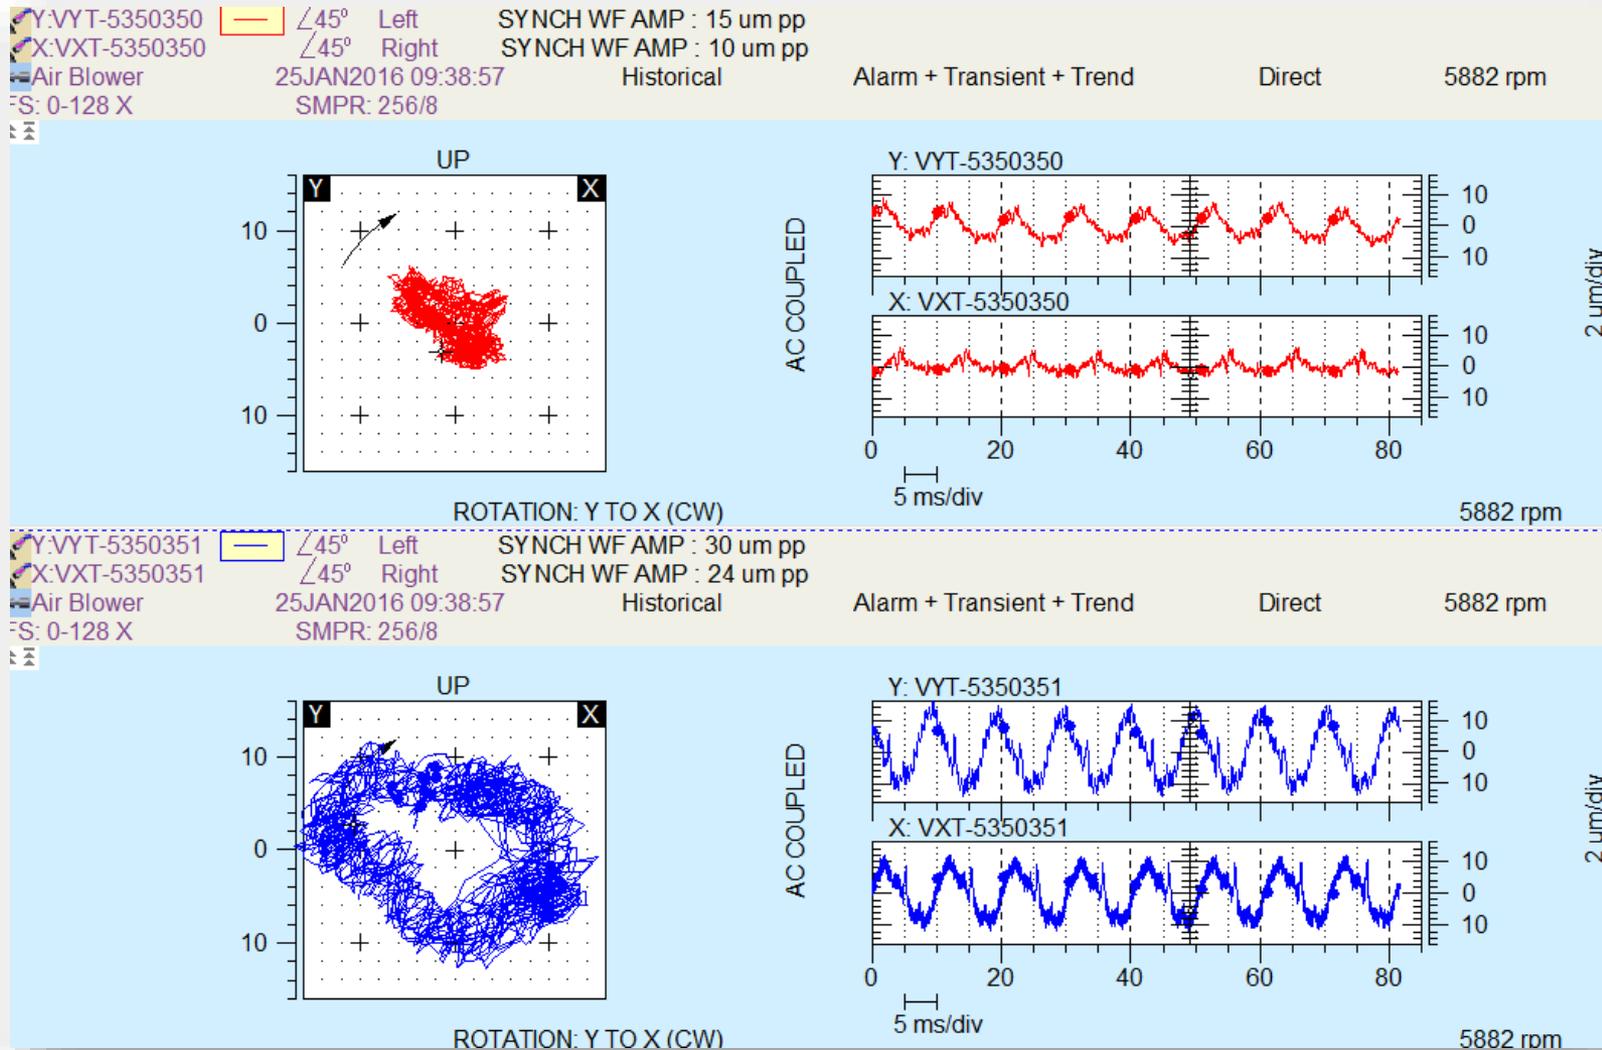
Orbit plots shows normal dynamic shaft movement
