# Wind Turbine Gearbox Bearing Material Analysis to Study Crack Nucleation, Propagation, and Damage Mechanisms

<sup>1</sup>Harpal Singh, <sup>1</sup>Raja Pulikollu, <sup>2</sup>Greg Smith

<sup>1</sup>*Sentient Science Corporation, Buffalo NY, USA*

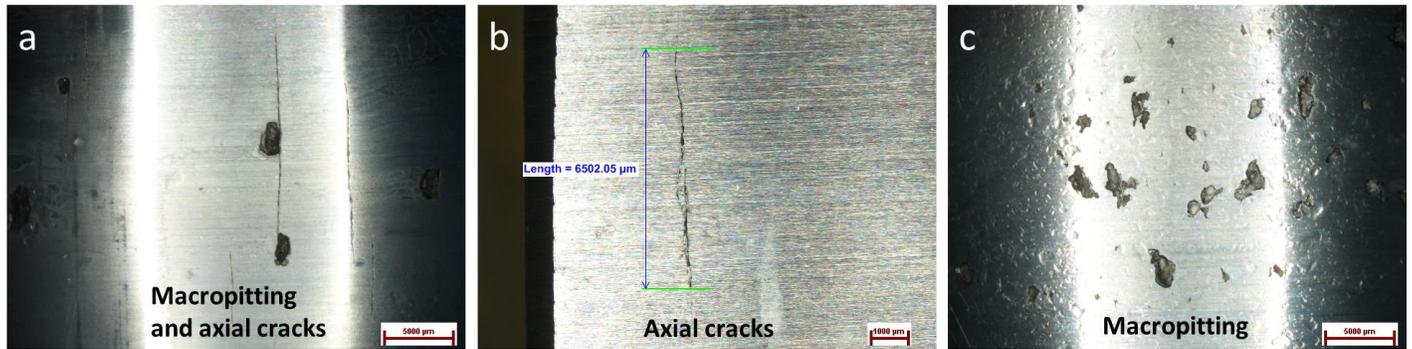
Figure 1 Macro-pitting and axial cracks on the inner raceway of through hardened martensitic steel bearings (a, b) and macropitting on bainitic bearing (c).

The wind turbine gearbox martensitic bearings failed either with macropitting or with both axial cracks and macropitting (Figure 1 a,b) whereas bainitic bearing failed with macropitting only (Figure 1 c) in agreement with the literature [2]. The sub-surface microstructure of the characterized bearings revealed altered microstructure (WECs). The measured Nano-hardness on the altered microstructure was about 27% higher than that of surrounding matrix which is consistent with the literature [3, 4]. The variation in the hardness values within the altered microstructure is most likely from the variable grain size and carbon composition in the localized areas [5].

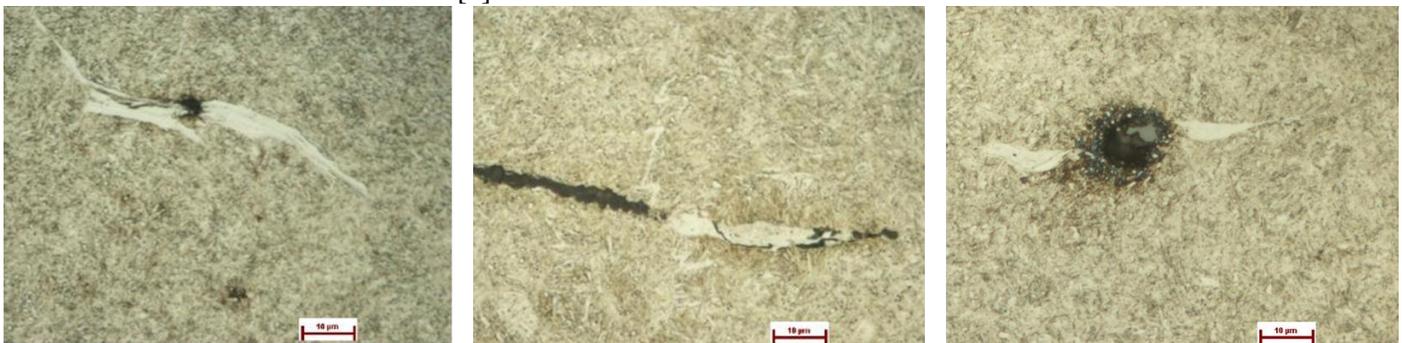
Butterfly wing formations were observed in planet stage bearings, while both butterflies and Ir-WECs were observed in high speed intermediate stage bearings. Butterfly wing formations in planet bearings were initiated at non-metallic inclusions in maximum shear stress sub-surface regions. Butterflies are developed by crack initiation at non-metallic inclusions that caused microstructural alteration by low temperature dynamic recrystallization of the highly strained regions in agreement with the literature [6, 7]. Butterfly formations are detected mainly in MnS and dual phase oxide inclusions. Only one Titanium Nitride (TiN) inclusion is identified with microstructural alteration. This relates well with the literature as TiN inclusions generally do not participate in butterfly formations [8]. Analysis shows higher likelihood of WECs formation around oxide and dual phase inclusion within the maximum shear stress zone than the MnS inclusion, which could be due to low deformability index and brittle character of oxide inclusions which makes them more detrimental than the sulfide inclusions [9].

Figure 2 Butterfly wing formation around non-metallic inclusions observed in planet stage and low speed intermediate bearings

The mean depth of butterfly generated inclusions are found close to the depth of maximum orthogonal shear stress in agreement with the literature [7, 10]. However, butterfly generated inclusions are also found near unidirectional maximum

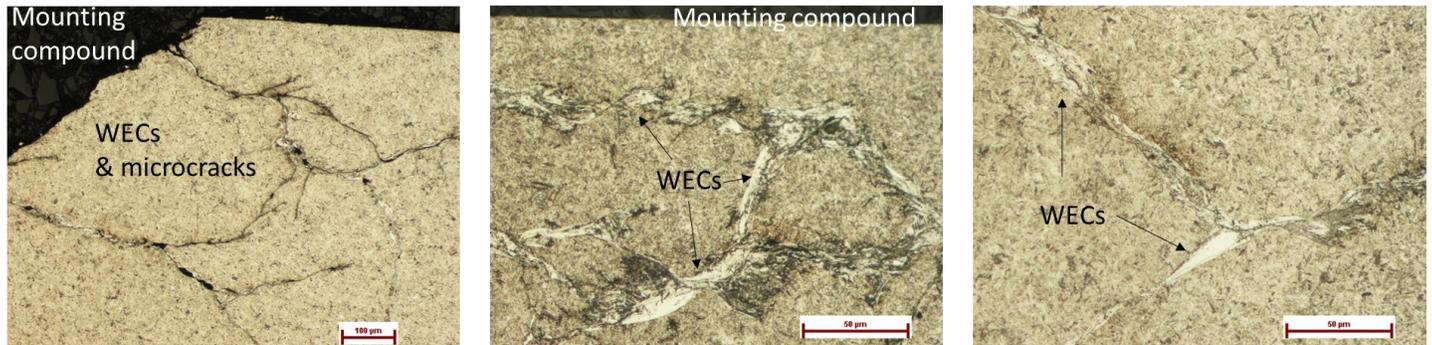
Ir-WECs observed in high speed stage bearings have optical appearance like butterflies with no preferred orientation as shown in Figure 3. Ir-WECs are connected through randomly oriented micro-cracks with and without white etched areas. Similar Ir-WECs have been observed earlier, which are proposed to be originated and propagated from the non-metallic inclusions [11, 13, 14]. However, butterflies can propagate as a single crack without forming multiple crack networks, which makes this hypothesis debatable.

Figure 3 Optical images of circumferential cross-section showing randomly oriented cracks and white etched areas close to the contact surface

The variation in circumferential spacing of the axial cracks observed on the high-speed intermediate stage bearings raceway suggests repeated loading conditions under which cracks are initiated and then allowed to propagate. High speed stage bearings experience large torque reversals at the time of generator-grid engagement and high torque peaks during sudden brakes that can induce excessive stresses than the designed loads. It is possible that excessive loads from transient events combined with tensile stresses initiated cracks [15]. Cracks once initiated either due to single or combination of factors can lead to the formation of WECs depending upon the cumulative number of cycles.

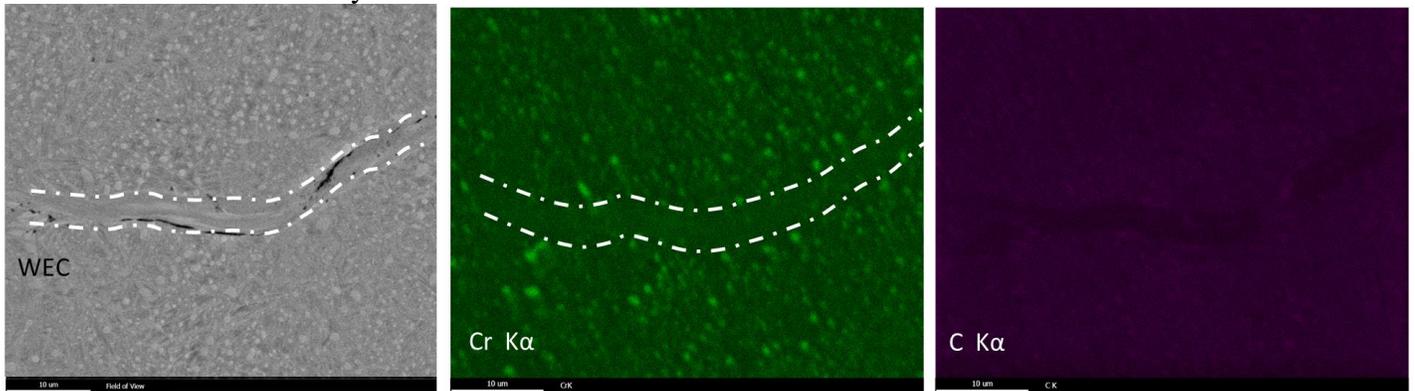
Figure 4 EDX maps of the WEA (a) SEM image (b) chromium map Cr-K $\alpha$  and (c) carbon map C-K $\alpha$

EDX mapping was used to reveal the distribution of Cr and C concentration in the WEC. The chromium and the carbon map distribution measured using EDX in the energy range of Cr-K $\alpha$  and C-K $\alpha$  are shown in Figure 4. Primary carbides are seen uniformly distributed in the unaltered matrix. In the altered matrix (WEA), no high intensity spots are visible. The EDX maps shows that Cr is depleted or homogeneously distributed in the WEA region.
