Case Study

Another Perspective: False Brinelling and Fretting Corrosion

By Robert Errichello
GEARTECH
Townsend, Montana

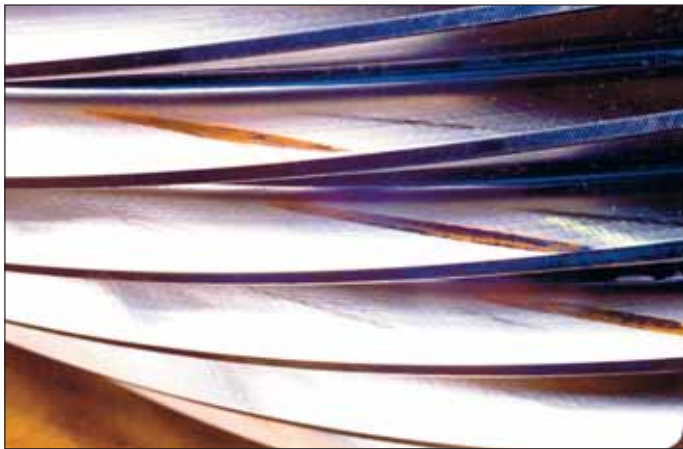
Figure 1.

As pointed out by Godfrey, a wind turbine gearbox is susceptible to fretting wear. Figure 1 shows the high-speed pinion from a modern wind turbine. With the high-speed pinion stopped by the brake, and the rotor buffeted by the wind, the mating gear rocks back and forth through small amplitude motion.

The four faint lines in Figure 1 are false brinelling that occurred when the wind turbine was parked for a short time under light winds. The three prominent red lines are fretting corrosion that occurred when the wind turbine was parked for an extended period under heavy winds.

False brinelling in a high-speed pinion from a modern wind turbine.

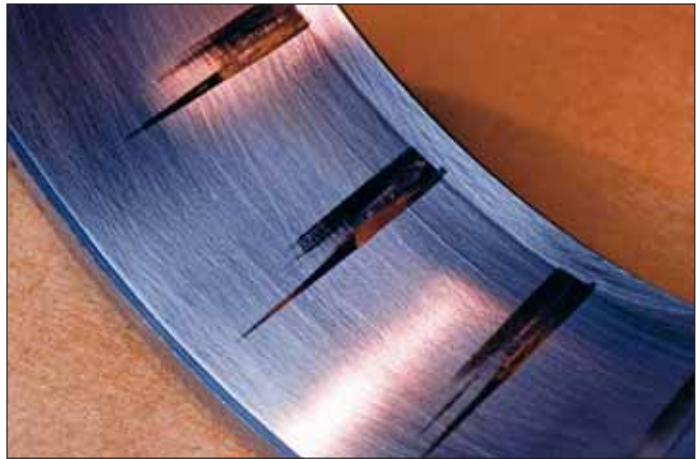
Figure 2.

Figure 2 shows the outer raceway of a rolling-element bearing, also from a wind turbine, which suffered false brinelling and fretting corrosion when the wind turbine was parked.

False brinelling and fretting corrosion in the outer raceway of a rolling-element bearing.

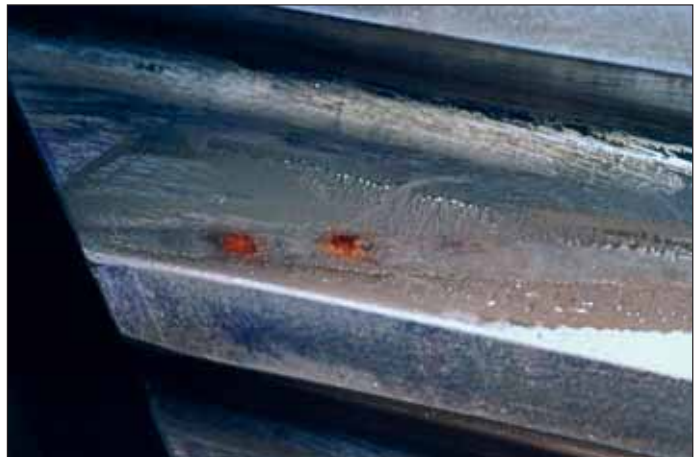
Figure 3 shows an area on the planet gear teeth with false brinelling. The contact area is surrounded by black debris assumed to be magnetite as described by Godfrey [1]. When magnetite powder mixes with oil in the meniscus around the contact, it forms a black mixture with the consistency of grease.

In some contacts with magnetite debris, the damage was limited to false brinelling. In other contacts with relatively large amounts of magnetite debris, the area of false brinelling had small patches of fretting corrosion at the center of the false brinelling scar as shown in Figure 3. Apparently, the magnetite debris formed a dam around the contact, which prevented oil from entering, and the contact eventually

False brinelling on planet gear teeth.

became unlubricated. Without lubrication, the damage escalated into fretting corrosion. This result corroborates Godfrey's [1] assertion that fretting corrosion occurs in unlubricated contacts.
