Case Study

Evaluation of a Gearbox's High-Temperature Trip

By Vinod Munshi, John Bietola, Ken Lavigne, Malcolm Towrie and George Staniewski (Member, STLE)
Ontario Power Generation,
Darlington Nuclear
Bowmanville
Pickering, Ontario,
Canada L1C 3W2

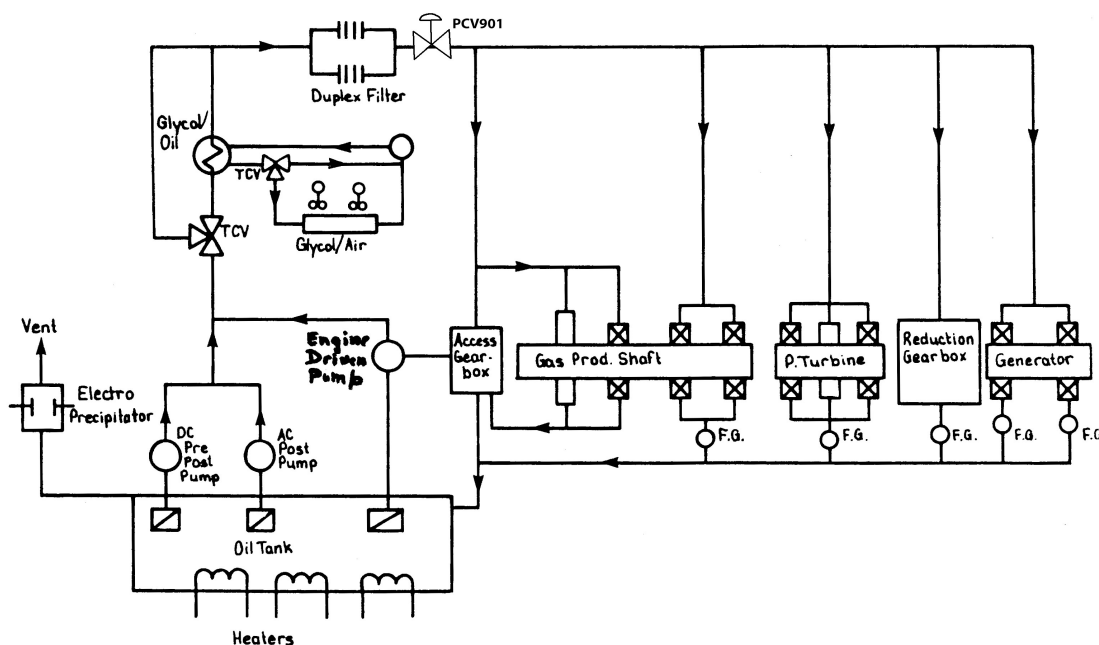
Figure 4. Simplified Lube Oil Schematic

A 24-hour test run was started July 14, 2002, to establish EPG2 reliability following maintenance on the fuel system and lowering of the lubricating oil pressure set point on pressure control valve PCV901. (See fig. 4) The test revealed EPG2 failed after 23.5 hours of operation at full load on high gearbox bearing oil drain temperature.

A 24-hour test run was started on July 14, 2002, to establish EPG2 reliability following maintenance on the fuel system. The lubricating oil pressure set point had also been lowered to match the recommended set point of 241 kPa (range 207-276 kPa).

The flooding was caused by excessive foaming of the lubricating oil inhibiting gearbox draining, as well as higher than normal oil flow to the gearbox caused by higher than recommended oil supply pressure. In addition, the team noted that the pressure in the vented lubricating oil tank was above atmospheric pressure due to the high level of air detrainment occurring. The pressure in the gearbox was slightly negative. The team concluded that this might have inhibited draining of the gearbox back to the tank.

The pressure control valve, PCV901, which regulates lubricating oil pressure, was rebuilt and another test run performed with pressure adjusted to 242 kPa and the flow rate reduced to 590 lpm. The lubricating oil level inside the gearbox dropped to three inches from the bottom of the gearbox casing, which is close to where the manufacturer expected the maximum oil level should

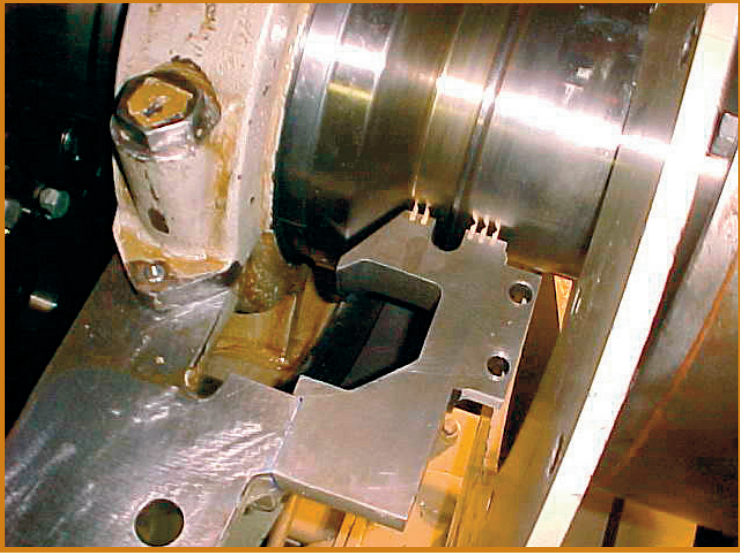
Figure 5. Gearbox bearing seal arrangement

A root cause team was formed following the EPG2 trip on July 15, 2002. The significance of the three coincident problems seen during the trip was missed at first and, initially, the gearbox bearing oil drain temperature high trip was thought to be due to a faulty RTD since the bearing was in excellent condition. The cause of the oil leakage was believed to be due to a combination of the gearbox pressurizing in conjunction with a low seal air supply pressure to the gearbox bearing oil seal. (See fig. 5)

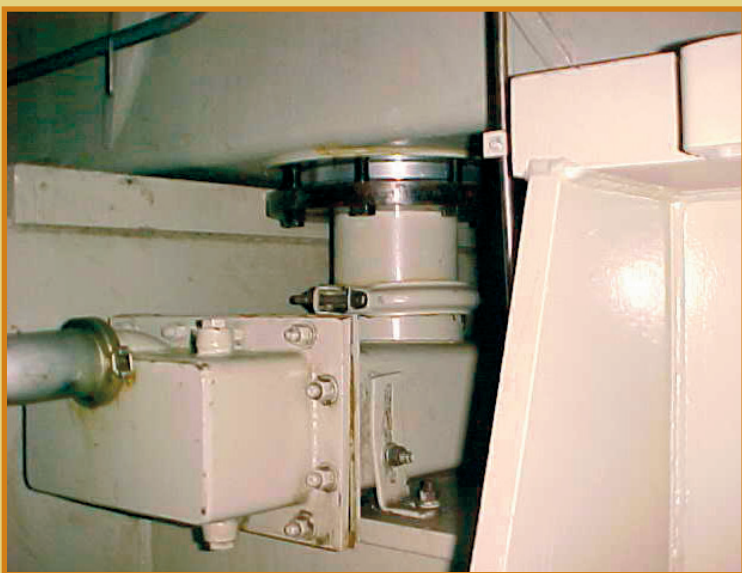
Figure 6. Oil drain arrangement from reduction gearbox

oil flow to the gearbox, foaming of the lubricating oil, and high differential pressure between the oil tank and the gearbox resulting in slower draining of the gearbox were investigated. The gearbox is a dry sump design and is fitted with a large, six-inch-diameter drain line to ensure that the oil doesn't hold up. (See fig. 6)

The gearbox is not vented. The air carried by the foam into the drain tended to keep the pressure in the gearbox slightly negative. The air detraining from the oil draining into the large oil tank kept this tank slightly positive, so air flowed from the tank along the drain header to the gearbox in the opposite direction to the draining oil. The flow of heavily foamed oil would be restricted by a contrary airflow.

A vent line connecting the gearbox to the lubricating oil tank will be installed to ensure that high pressure in the oil tank due to air detrainment and slight vacuum in the gearbox doesn't cause inhibit draining. Furthermore, the oil level is expected to drop further after the modification is installed. This was confirmed during field tests when the gearbox was vented to the atmosphere and the oil level dropped by 0.5 inches. The lubricating oil for the EPG2 has since been replaced.
