## 2018 STLE Annual Meeting & Exhibition

### FORMATION OF WHITE ETCHING CRACKS (WEC) UNDER ROLLING LOADING IN A TWO-DISC TEST RIG AND A KINEMATIC STUDY ON A FULL-SCALE BEARING

Rolling Element Bearings II, May 21, 2018

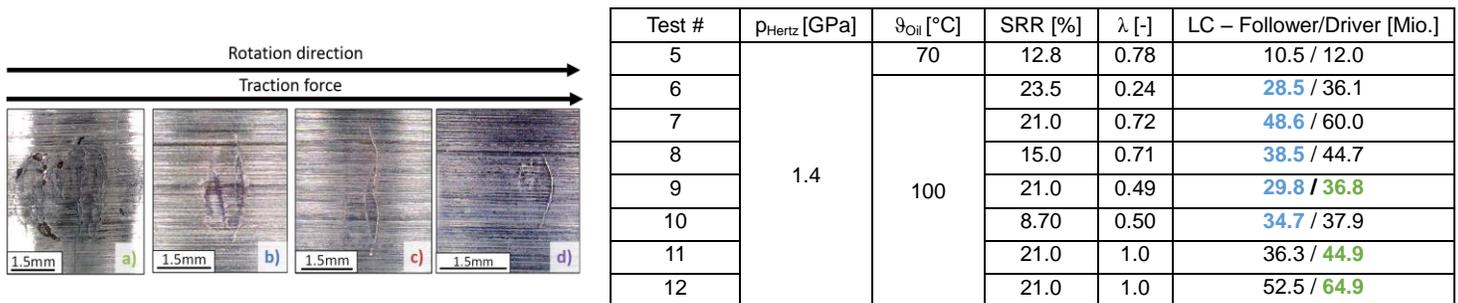
Figure 1: Images of the follower surfaces from test 6 (a), 7 (b), 8 (c) and 9 (d) and testing conditions of the second test series

The four tests running under full fluid lubrication were stopped after  $40 \cdot 10^6$  cycles and showed no macroscopic signs of surface damage. Metallographic inspections conducted at the Institute for materials applications in mechanical engineering (IWM) on selected rings showed no WEC. The testing conditions and results of the second test series are shown in **Figure 1**. Aside from test 5, which was stopped after  $12 \cdot 10^6$ , all tests were concluded when a spall failure occurred. Within these tests, five followers (color-coded blue) and three drivers (green) showed spalling as well as WEA/WEC. The development of surface spalling can be observed exemplary in **Figure 1**. Selected metallographic inspections showing WEA/WEC are shown in **Figure 2**. As RCF proceeds, a cluster of micro-cracks is formed, which ultimately leads to spalling of material. In addition, the driver from test 6 showed also axial cracks, **Figure 3**.

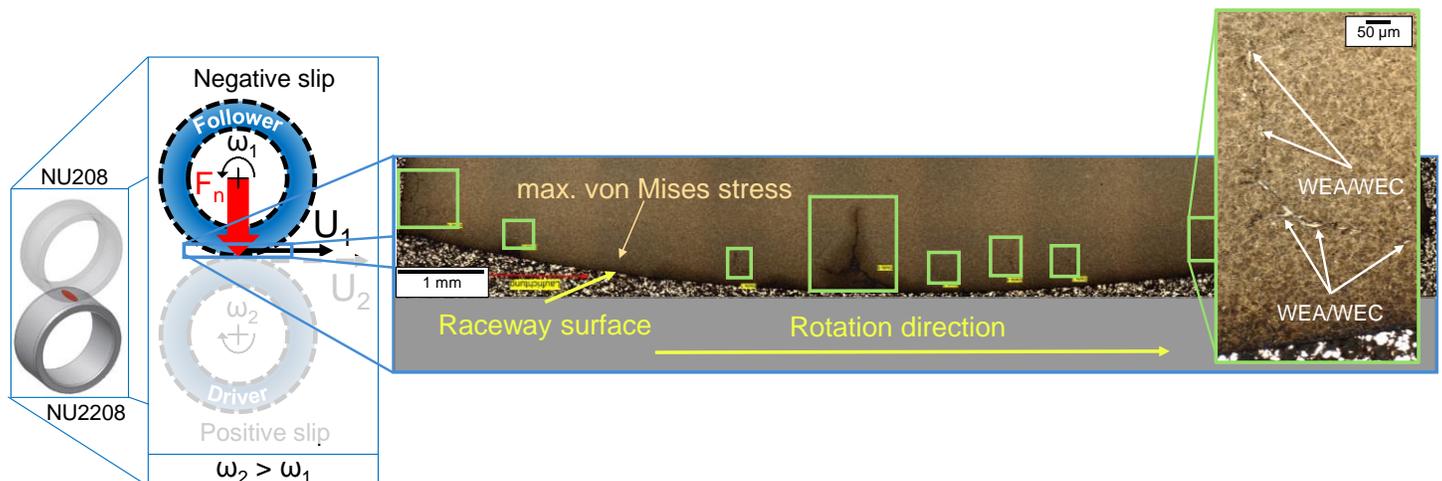
Figure 2: Selected metallographic inspections on a follower showing WEA/WEC

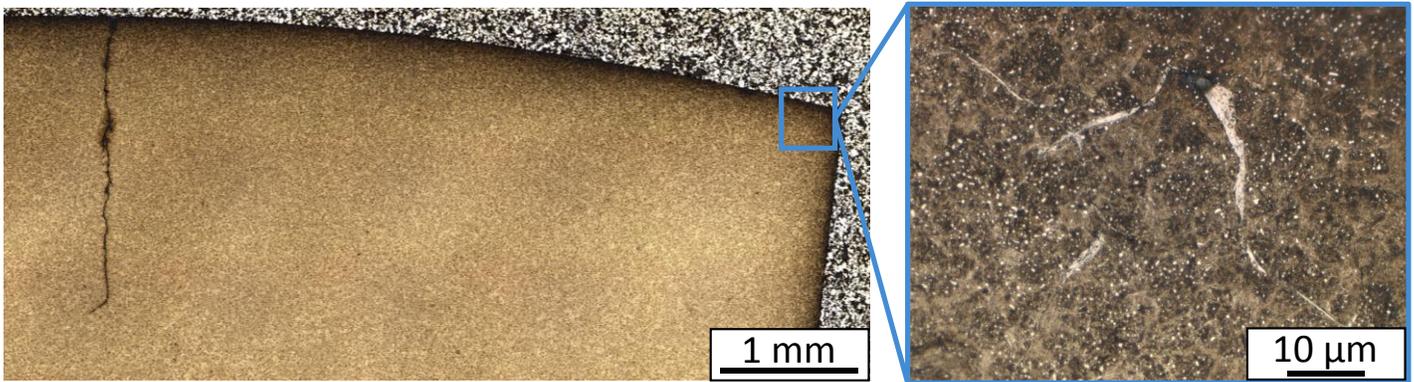
Figure 3: Metallographic inspections on the driver from test 6 showing an axial crack and WEA/WEC

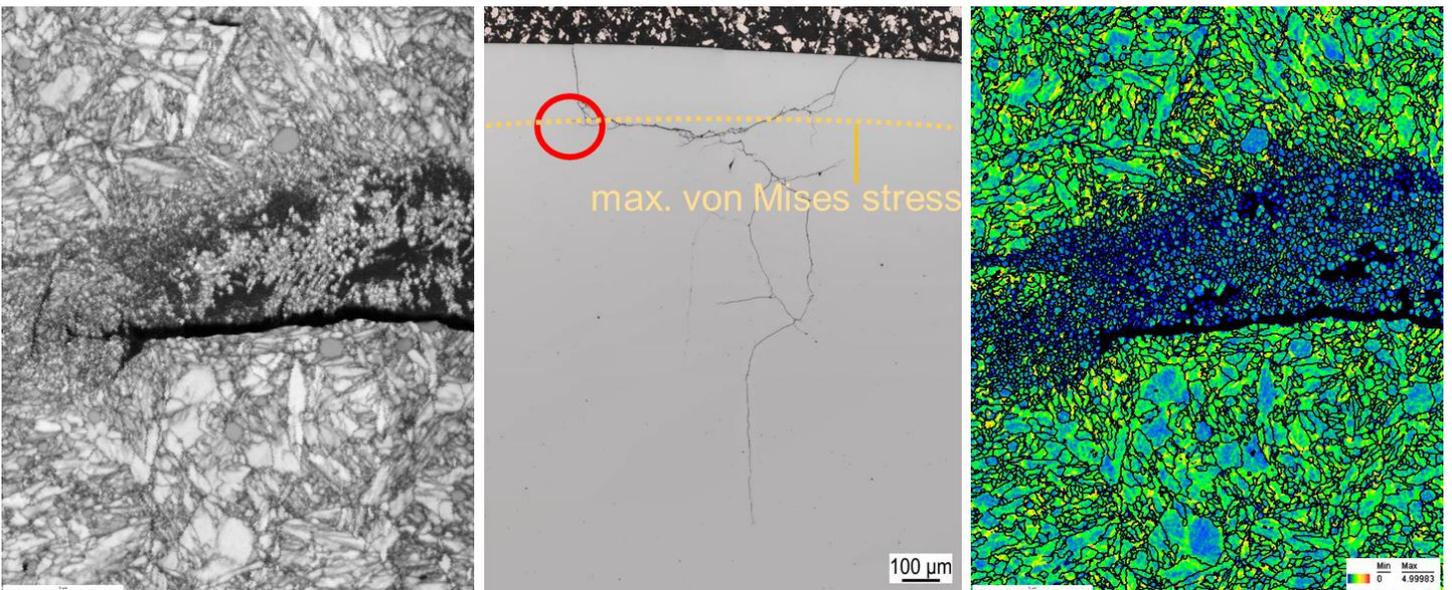
Figure 4: 1) IQ-Map 2) Light optical Image 3) KAM Map of test 10

Investigation of the microstructure was carried out through electron backscatter diffraction (EBSD) to determine the origin of the damage. It is not fully understood yet, when WEA exactly form and whether they form before or after cracking of the material. EBSD provides crystallographic information for each measured point to gain knowledge about processes in the microstructure after the failure happened. **Figure 4** shows a crack alongside a big WEA from test 10. The investigated crack tip is located in the region of the maximal von Mises stress. It is clearly seen that the tip of the crack is located in the region of maximal von Mises stress. The Image Quality (IQ) shows the altered microstructure next to the crack. The former martensitic structure was changed into a nanocrystalline ferrite microstructure, which started to grow into bigger ferrite grains. The Kernel Average Misorientation (KAM)-Map shows a big area of low misorientation. This indicates a recrystallization occurred in this region. Dislocations accumulate at grain boundaries or defects in the microstructure. As soon as enough energy is stored, microstructure change can occur through transformation of the structure in the form of recrystallization. The new ferrite grains grow equiaxed and thus have a low misorientation, appearing blue in the KAM-Map. Because of Hall-Petch hardening, the former nanocrystalline WEA was much harder than the surrounding martensitic structure. A possible result are WEC alongside the WEA. The findings in this study may support the thesis, that energy is stored through movement of dislocations in the depth of maximal von Mises stress, resulting in a microstructure transformation before a crack is formed.

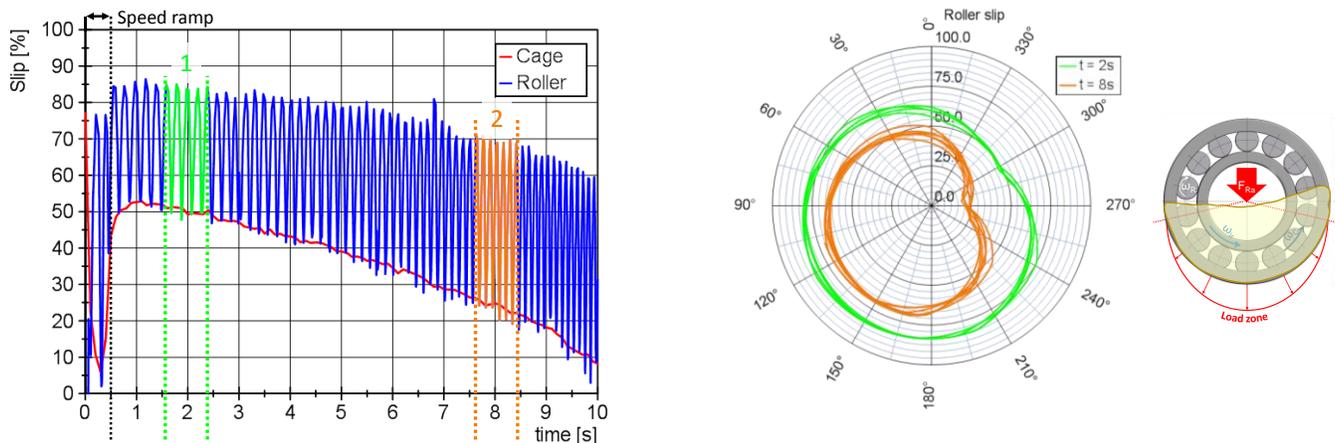
**Figure 5: Measured cage and roller slip during and after a speed ramp**

With regard to the question if high sliding conditions may occur in loaded radial roller bearings, the kinematic response of the bearing NU2330-E-M1/C3 to a speed ramp under constant load is shown in **Figure 5**. It becomes evident that high cage and roller slip occur during and after the speed ramp. This high-slip phase – caused by the rapid acceleration – appears in spite of the prevailing radial load of 50 kN (850 MPa). The slip state diminishes over time, but is observable for over 10 seconds (approximately 250 shaft rotations). For the purpose of comparing the kinematic response of the roller over time, two time intervals (of one second each) of this test are plotted as a function of the angular position of the roller relative to the shaft axis (**Figure 5-right**). The first interval (green) is set about one second after the speed ramp is concluded. At this point, the roller slip varies between 50 % (86 % SRR) and 85% (157 % SRR) – within and beyond the load zone respectively – while the cage slip has a mean value of about 50%. The second time interval (orange) starts seven seconds after the speed ramp is concluded. It can be seen that the roller slip has decreased up to 25 - 70 % (38 - 120 % SRR) – within and beyond the load zone respectively. From this measurements, it can be concluded that the speed ramp under constant load can lead to high-sliding conditions under moderate loading.
