# Studies in plain bearing failures

## By Patrick G. Swan, Aswan Consulting Cc Kenilworth, Cape Town, South Africa

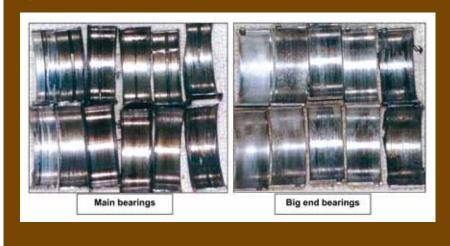
### Figure 3.

resulting in a diminished flow of lubricant to the bearings. Because the big end bearings rotate about the main bearings and are lubricated via the main bearings, the crankshaft becomes a centrifugal pump, and the available lubricant supply preferentially feeds the big end bearings. A typical example is shown in Figure 3. Note how the main bearings are more severely damaged than the big end bearings.

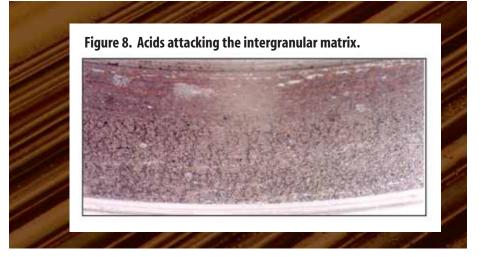
Oxidation occurs during the service life of a lubricant, which produces acids. In engines strong acids are produced from combustion. Acids attack the intergranular matrix, as seen

in Figure 8. In addition, further corrosion will break out larger grains of material resulting in bearing failure.

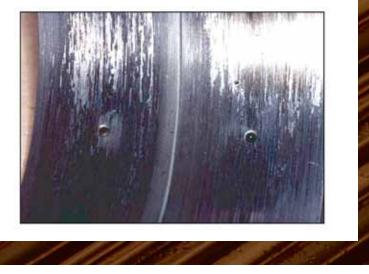
Figure 9. A bearing which shows the operating temperature above the overlay material melting point.

Heat is generated in bearings by friction in the lubricant as it forms an oil wedge. By definition viscosity is the lubricant's resistance to shear; thus, higher viscosity lubricants and bearings operating under higher loads stabilize at higher operating temperatures. The bearing material chosen for any operation must have a melting point higher than the operating temperature. Figure 9 shows a bearing where the operating temperature was above the overlay material melting point.
