Case Study

Evaluation of a Gearbox's High-Temperature Trip

By Vinod Munshi, John Bietola, Ken Lavigne, Malcolm Towrie and George Staniewski (Member, STLE)
Ontario Power Generation,
Darlington Nuclear
Bowmanville
Pickering, Ontario,
Canada L1C 3W2

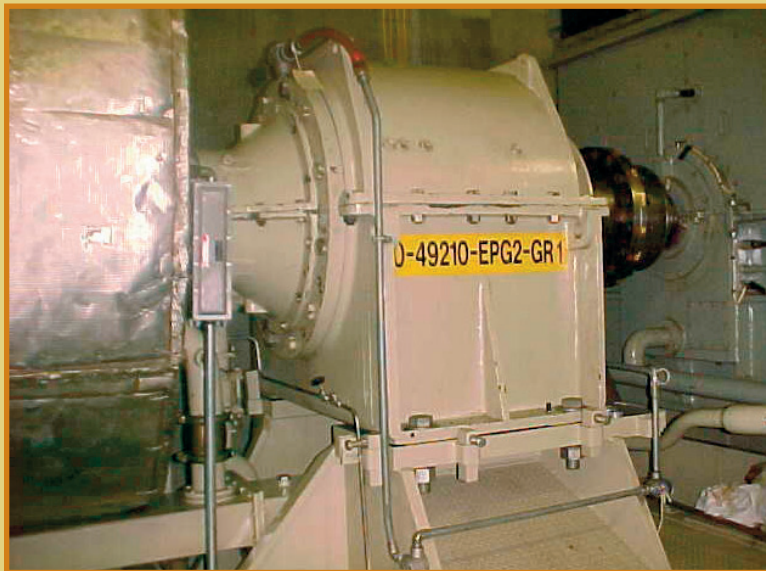
Figure 3. Reduction gearbox

The conclusion reached by the team was that EPG2 tripped on high gearbox bearing oil drain temperature due to flooding of the gearbox with oil and consequent churning of the oil inside the gearbox caused by rotating parts (planetary gear train) coming in contact with the oil.

The flooding was caused by excessive foaming of the lubricating oil inhibiting gearbox draining, as well as higher than normal oil flow to the gearbox caused by higher than recommended oil supply pressure. In addition, the team noted that the pressure in the vented lubricating oil tank was above atmospheric pressure due to the high level of air detrainment occurring. The pressure in the gearbox was slightly negative. The team concluded that this might have inhibited draining of the gearbox back to the tank.

The manufacturer of the gearbox estimated that the churning of the oil could result in an increase in load of 400 to 800 kW depending on the height of the oil level. The churning caused the oil in the gearbox to heat up rapidly. This hot oil splashed on the temperature detector located just below the main output shaft bearing, causing it to falsely indicate a high bearing temperature, which resulted in the EPG2 trip. The gas turbine manufacturer has independently confirmed that this effect has been seen before on different machines (albeit with a higher speed step-up gearbox).

Lowering the lubricating oil pressure to the manufacturer-recommended set point resulted in a significant reduction in the lubricating oil level (from approximately seven inches to three inches from the bottom of the gearbox). The lower oil level, coupled with a successful EPG2 extended test run (40 hours), has confirmed that the EPG2 failures occurred due to the flooding of the gearbox. Also, the reduced flow into the gearbox allowed the gearbox to drain effectively, and the flooding problem was resolved.
