Surface Engineering I (Session 3E)

**Inhibitory Effect of the Sliding Surface Damage due to the Discharge**

Kenji Matsumoto, STLE Member  
Honda R & D Co. Ltd., Utsunomiya, Japan  
Naoki Yoshida  
Kyushu University, Fukuoka, Japan  
Akira Sasaki, STLE Fellow  
Maintek Consultant, Yokohama, Japan

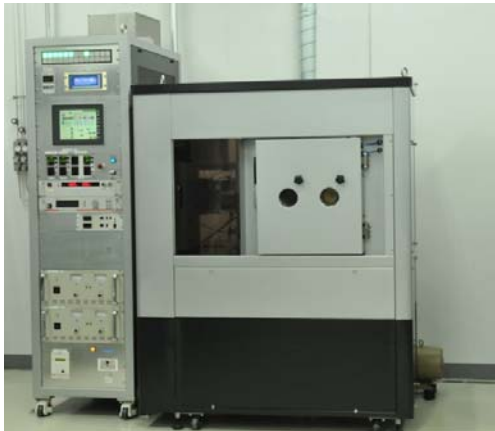
DLC film was formed on the surface of bearing balls using the apparatus shown in Fig. 1.

For making the DLC film, an ionized vapor deposition was used. The used materials were the mixed gases of benzene and tetramethylsilane.

### Figure 1. CVD/PVD film forming apparatus
