LUBRICATION FUNDAMENTALS

Dr. Robert M. Gresham / Contributing Editor

Manure spreader tribologyredux

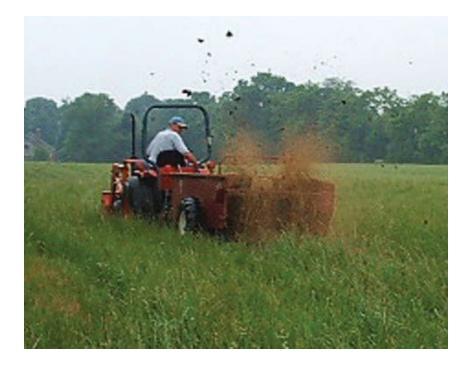
Figure 1 | Manure spreader.

A manure spreader manages a significant hygienic issue in an ecologically sound manner by recycling nutrients to the soil and increasing the amount of topsoil so more nutrients can be grown to feed livestock. Accumulated manure can pose serious run off problems, cause bad odor, result in bacterial, fungal and insect infestation and have a displeasing landscape. This is not trivial as the average horse generates 25 lbs. of manure per day, plus any urine-soaked bedding, leftover hay, etc. You can soon create a small mountain of very biologically live material in no time at all—which is great for the garden and flower beds. For people with livestock, this task is carried out 24/7, every month of the year. Figure 1 shows a manure spreader in action on a good day—it is only lightly raining.

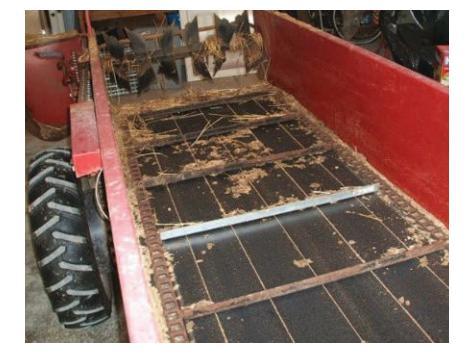
So what about the tribology of a manure spreader? As you can see, it is essentially a two-wheeled wagon. In the older designs, the wheel bearings are sealed from the manufacturer and, thankfully, require little maintenance that's just about all the good news. In Figure 2, looking into the bed, we see two chains on either side with simple angle iron pieces spaced evenly running from chain to chain. As the chain is pulled toward the back of the wagon, the manure is fed slowly into whirling paddles that spread and disperse the manure evenly out the back.

Figure 2 | Two-wheeled wagon.

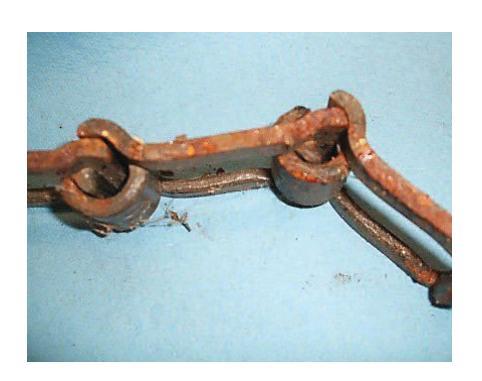
Figure 3 | Old chain.

edges that preclude coatings or most lubricants to protect them from corrosion. Further, the bearing surfaces are also rough, adding to friction and wear (*see Figure 3*). The new chains are made from rod stock so the only rough edges are on the cut ends (*see Figure* 4), thus they have an inherently more corrosion-resistant shape and better bearing surfaces.

First, the chains on the old system are inexpensive metal stampings. This means that they have relatively sharp

The older chains have another remarkable property. They only seem to break at below 20 F, especially if it is windy and snowing. As time goes on, constant exposure to the elements, manure, urine and wet bedding eventually corrode and weaken the chain. The stresses of winter put more strain on the chain, further increasing the probability of failure. Repair is simple enough: the tension on the chain is released, the chain is bent into position with just a few light taps of a hammer, the old link is removed and the new one installed. This repair, of course, happens only out in the field and only on a cold, windy, snowy day-during daylight if you're lucky. The manure must first be dug out of the spreader, by hand, to access the chain. The light taps of the hammer are actually a barehanded, knuckle-busting, operation that takes only a few seconds. However, the new chains are thicker, so it will take longer for wear/corrosion to do their damage. Also (and most important) they interlock simply, which can easily be done with a gloved hand. The new chains also are relatively inexpensive.

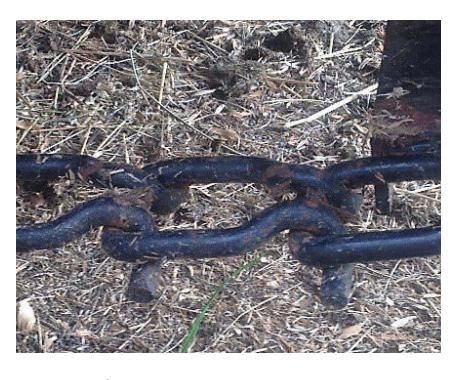
Figure 4 | New chain.

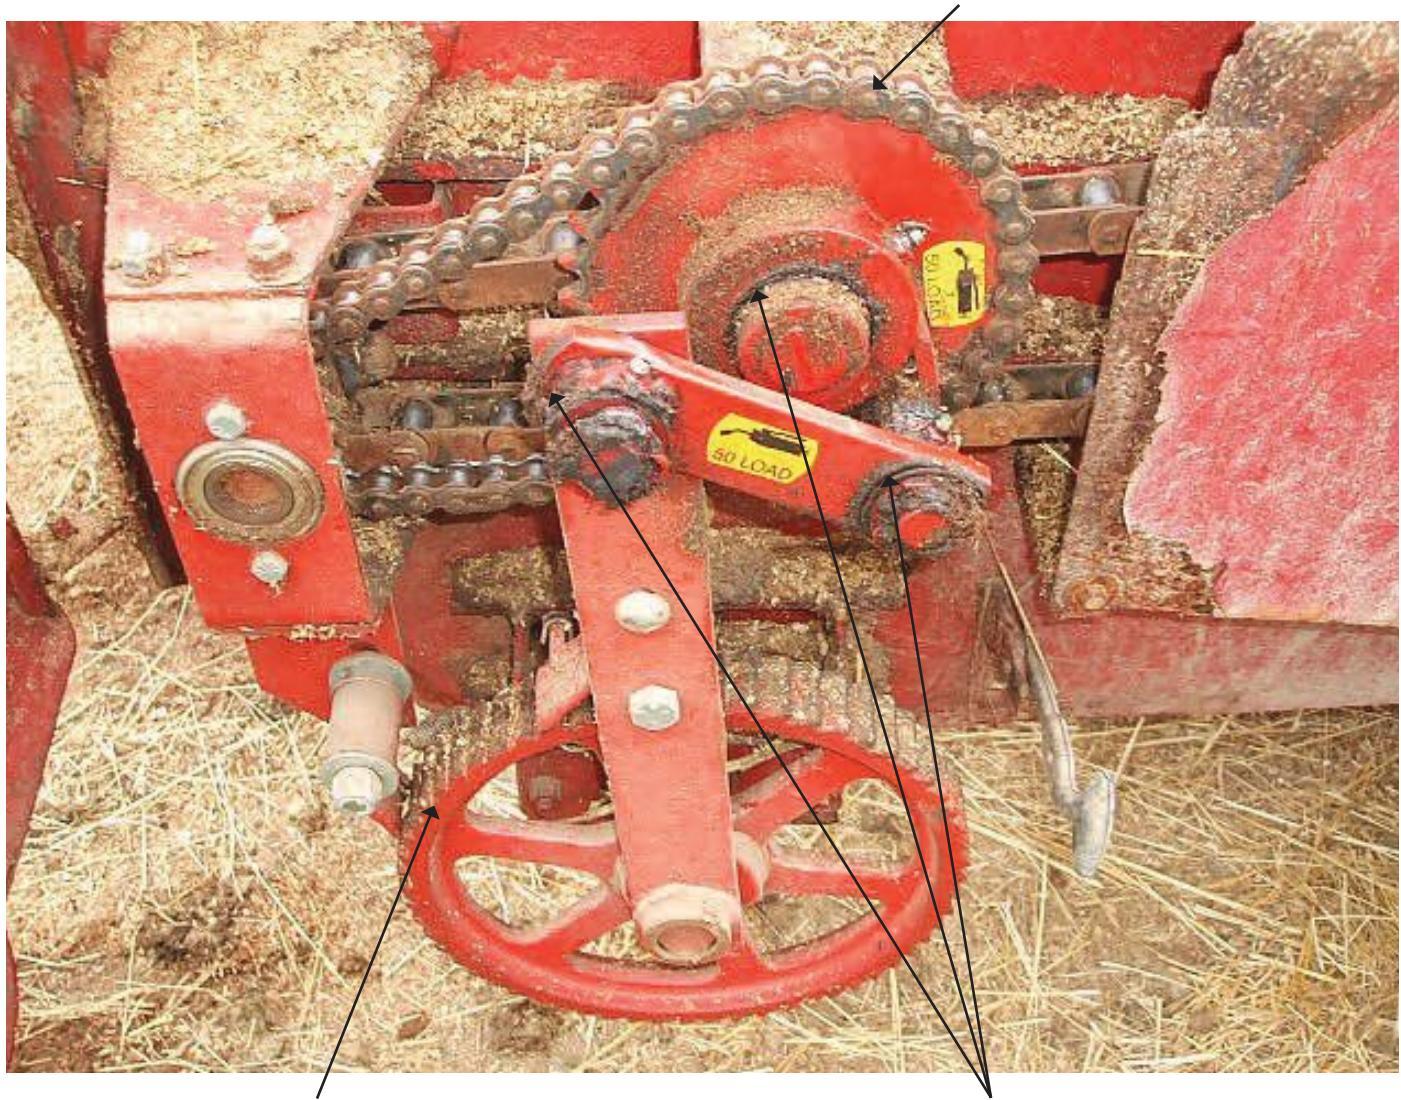
The next area of tribological interest is the ratcheting mechanism that pushes the manure into the whirling paddles to spread the manure. As shown in Figure 5, the older design mechanism is driven by another chain (like a big bicycle chain) that, when engaged, runs off a large gear attached to the wheel of

Drive chain

Ratchet gear

Grease points

Figure 5 | Ratcheting mechanism.

the wagon. As the spreader is moved, the chain is moved. The mechanism has a large ratchet gear and a couple of smaller sprockets (all iron castings) that turn on a stationary journal. Each of these must be regularly greased (yes, in the rain and snow) with a good molybdenum disulfide-containing grease that preferably also contains corrosion inhibitors. Fortunately with regular maintenance, these greases perform well, and failures are rare. There are normally shrouds that cover this mechanism. Nonetheless, manure, rain and related detritus get in and around the mechanism. In Figure 5 you can readily see the corrosion on the forward shroud (to the right) that covers the bicycle chain running to the drive gear wheel.

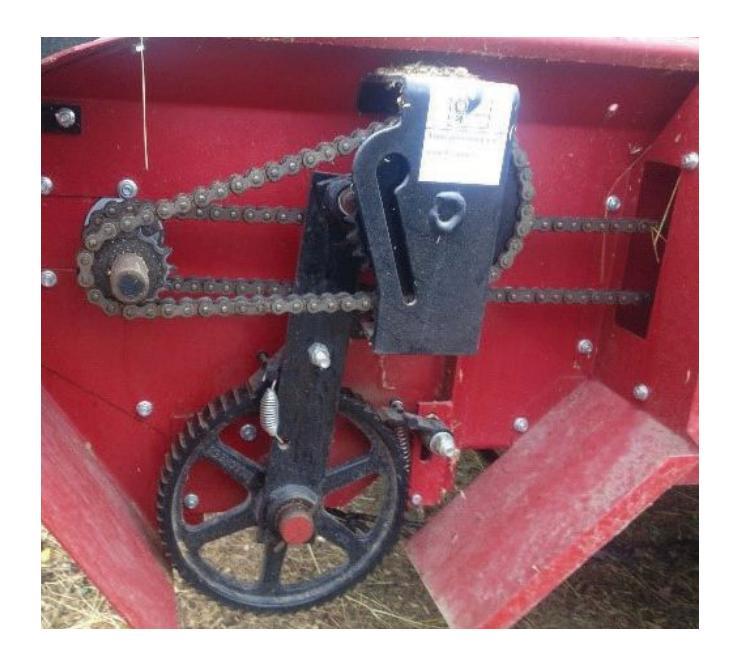
The new design in Figure 6 (notice how much cleaner everything is) is similar in function but with a better housing to protect from rain and corrosive elements and with lube-forlife bearings, so only minor periodic maintenance is needed to oil the chain and inspect for ratchet wear and loose bolts.

Figure 6 | Newer design of ratcheting mechanism.

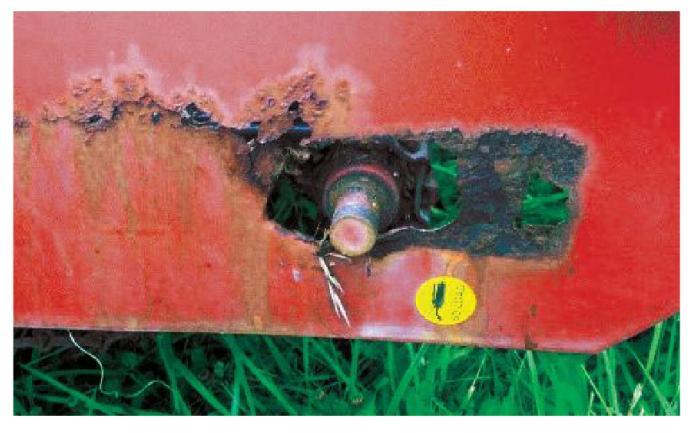
Figure 7 | Old rusted bearing.

As illustrated in Figure 7, the older design had the manually greased, difficult-to-reach, open-rear spreader bearing mounted on sheet metal that was in an area severely contaminated by manure itself. The newer design (see *Figure 8*) has lube-forlife bearings sealed from contamination and mounted on an eighth inch backing plate that easily could be replaced were it to corrode badly.

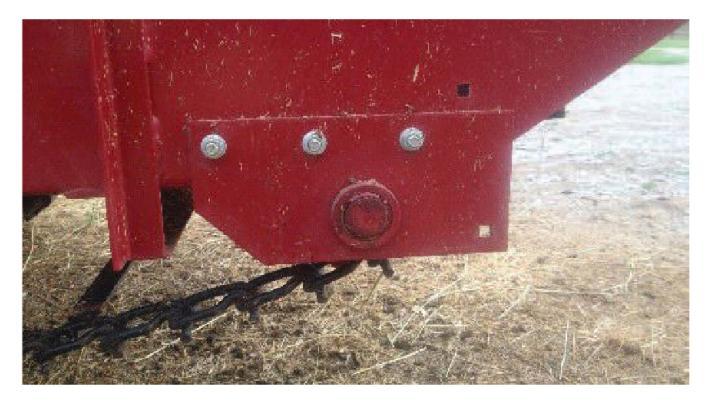
Figure 8 | New bearing assembly.
