On-the-horizon lubricants just might be the best solution to the high loads and extreme conditions that cause early failures.

# EXTENDING WIND TURBINE GEARBOX LIFE WITH LUBRICANTS

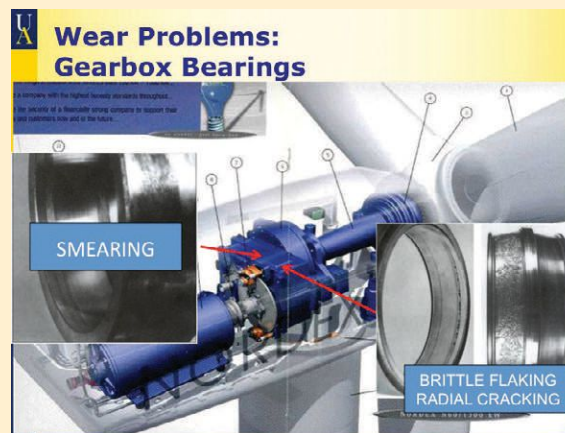
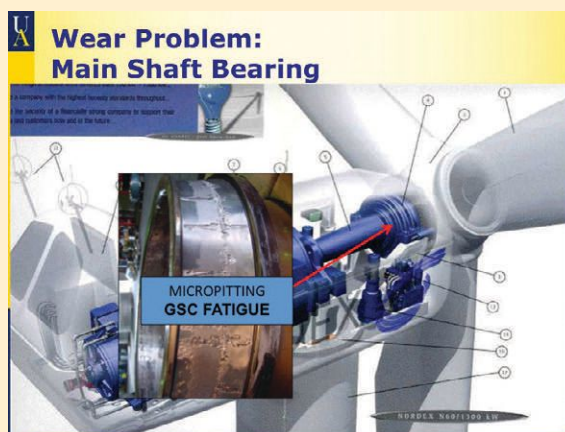
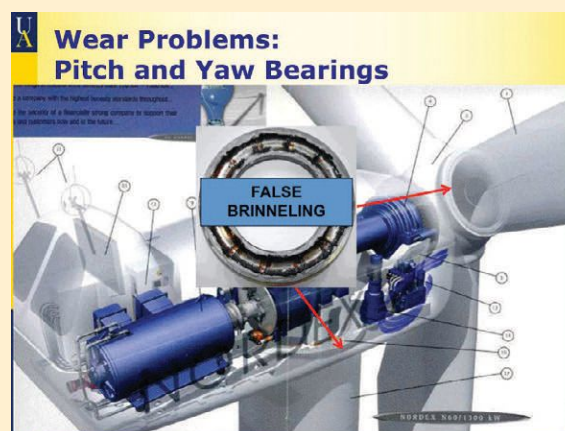
Illustrations courtesy of The University of Akron

**W**hat goes on inside a wind turbine? STLE-member Dr. Gary Doll, Timken Professor of Surface Engineering at the University of Akron, describes the key components.

**Mainshaft.** The most common wind turbine configuration (<2MW) uses two bearings: a spherical roller bearing on the blade side and a cylindrical roller bearing on the generator side.

**Generators.** Ball bearings are used to support the shafts in generators. These bearings are either all-steel with an electrically insulating coating on the outer rings or a hybrid variety that employs ceramic rolling elements with steel rings.

**Pitch and yaw systems.** Large wind turbines (>250kW) use ball bearings in the pitch and yaw systems. These are typically either 4- or 8-point ball bearings with a gothic arch design.

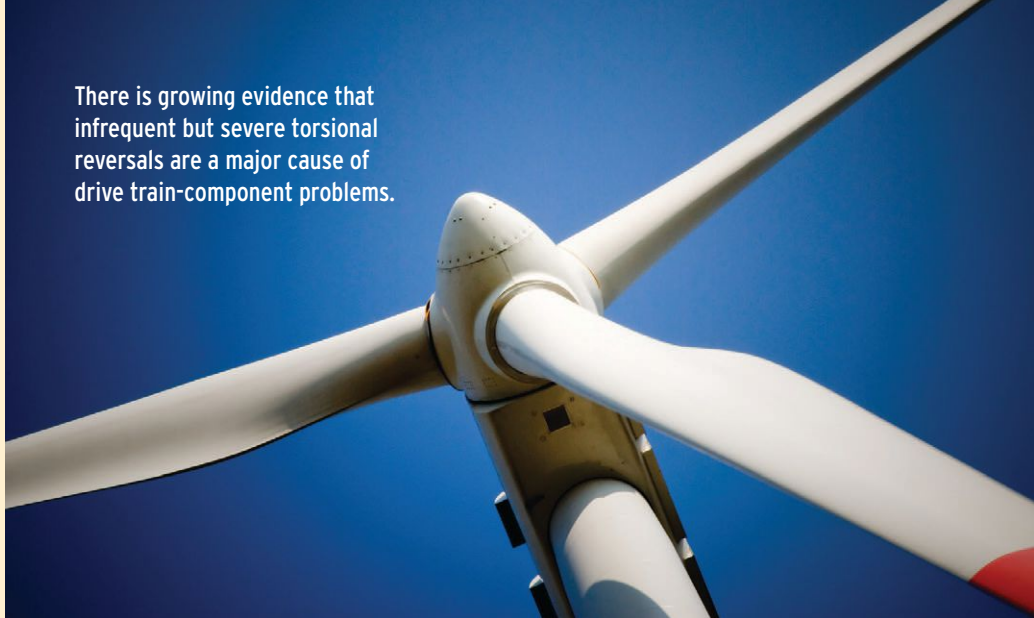
There is growing evidence that infrequent but severe torsional reversals are a major cause of drive train-component problems.
